Hyattsville Accessibility Transition Plan

Hyattsville Municipal Building Ward 1 Voting Location

Hyattsville Municipal Building - Hyattsville Transition Plan

Address: 4310 Gallatin Street

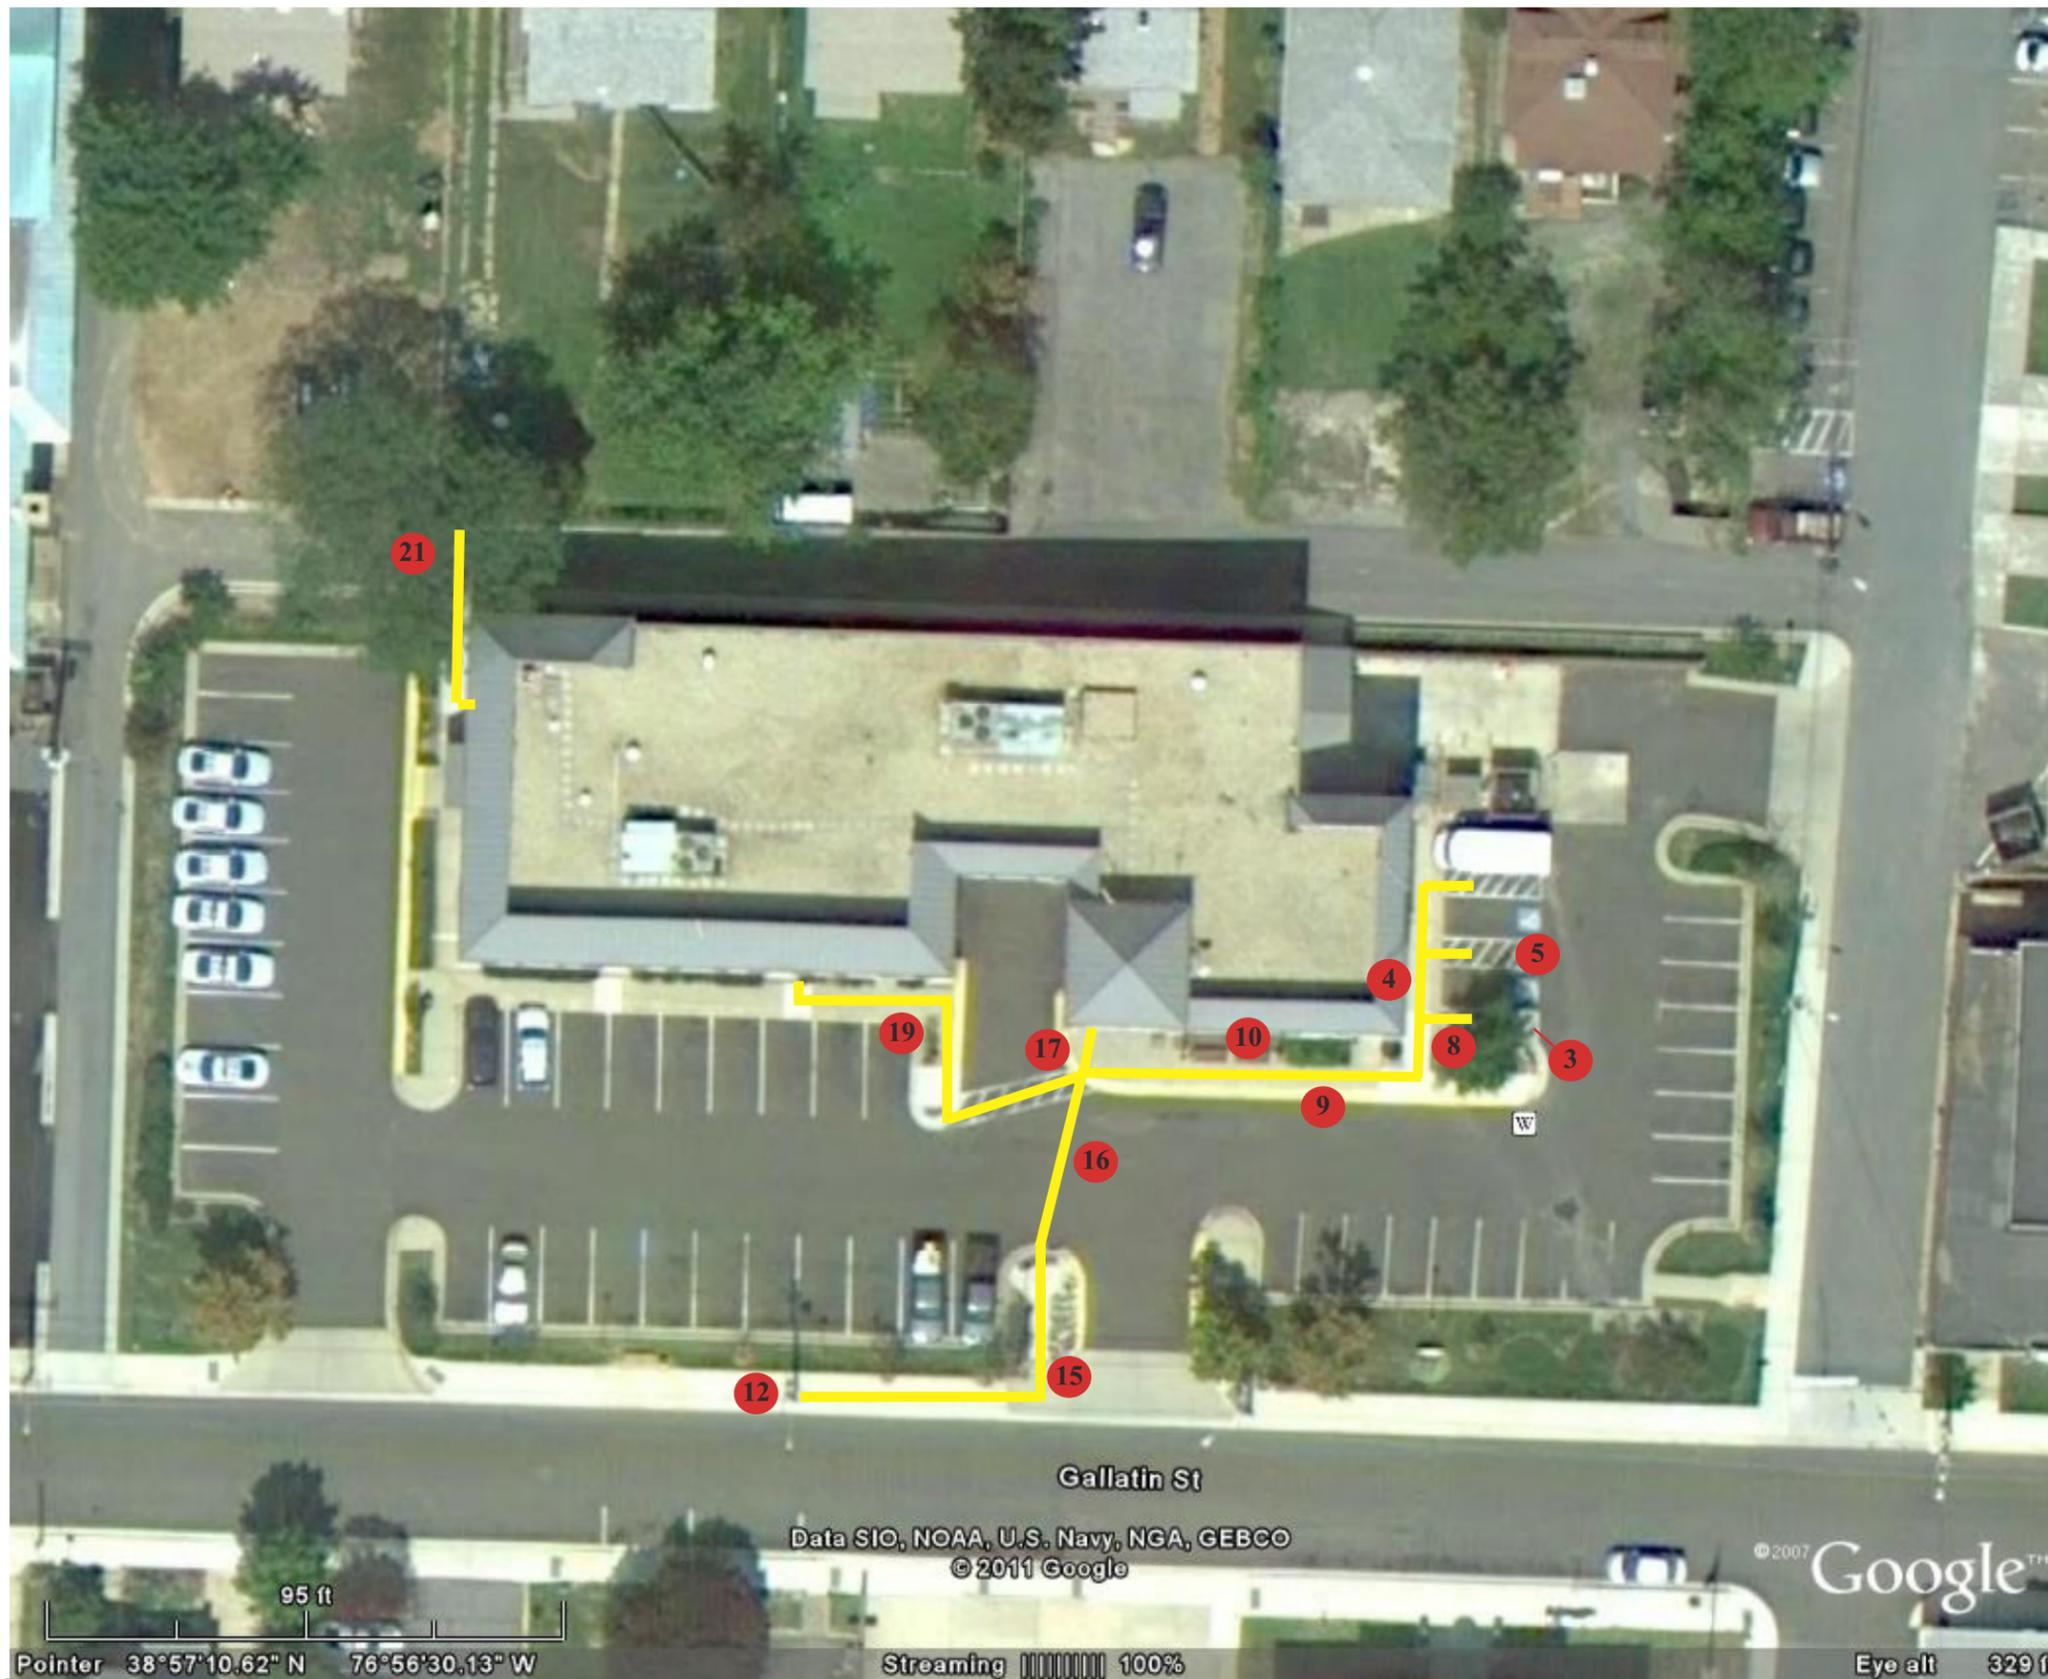
- Proposed solutions - see red item numbers on the Transition Plan spread sheets that follow this page

- Accessible route

- Accessible surface at play equipment (approximate area)
