Hyattsville Accessibility Transition Plan

University Christian Church (Ward 3 Voting Location)

6800 Adelphi Road

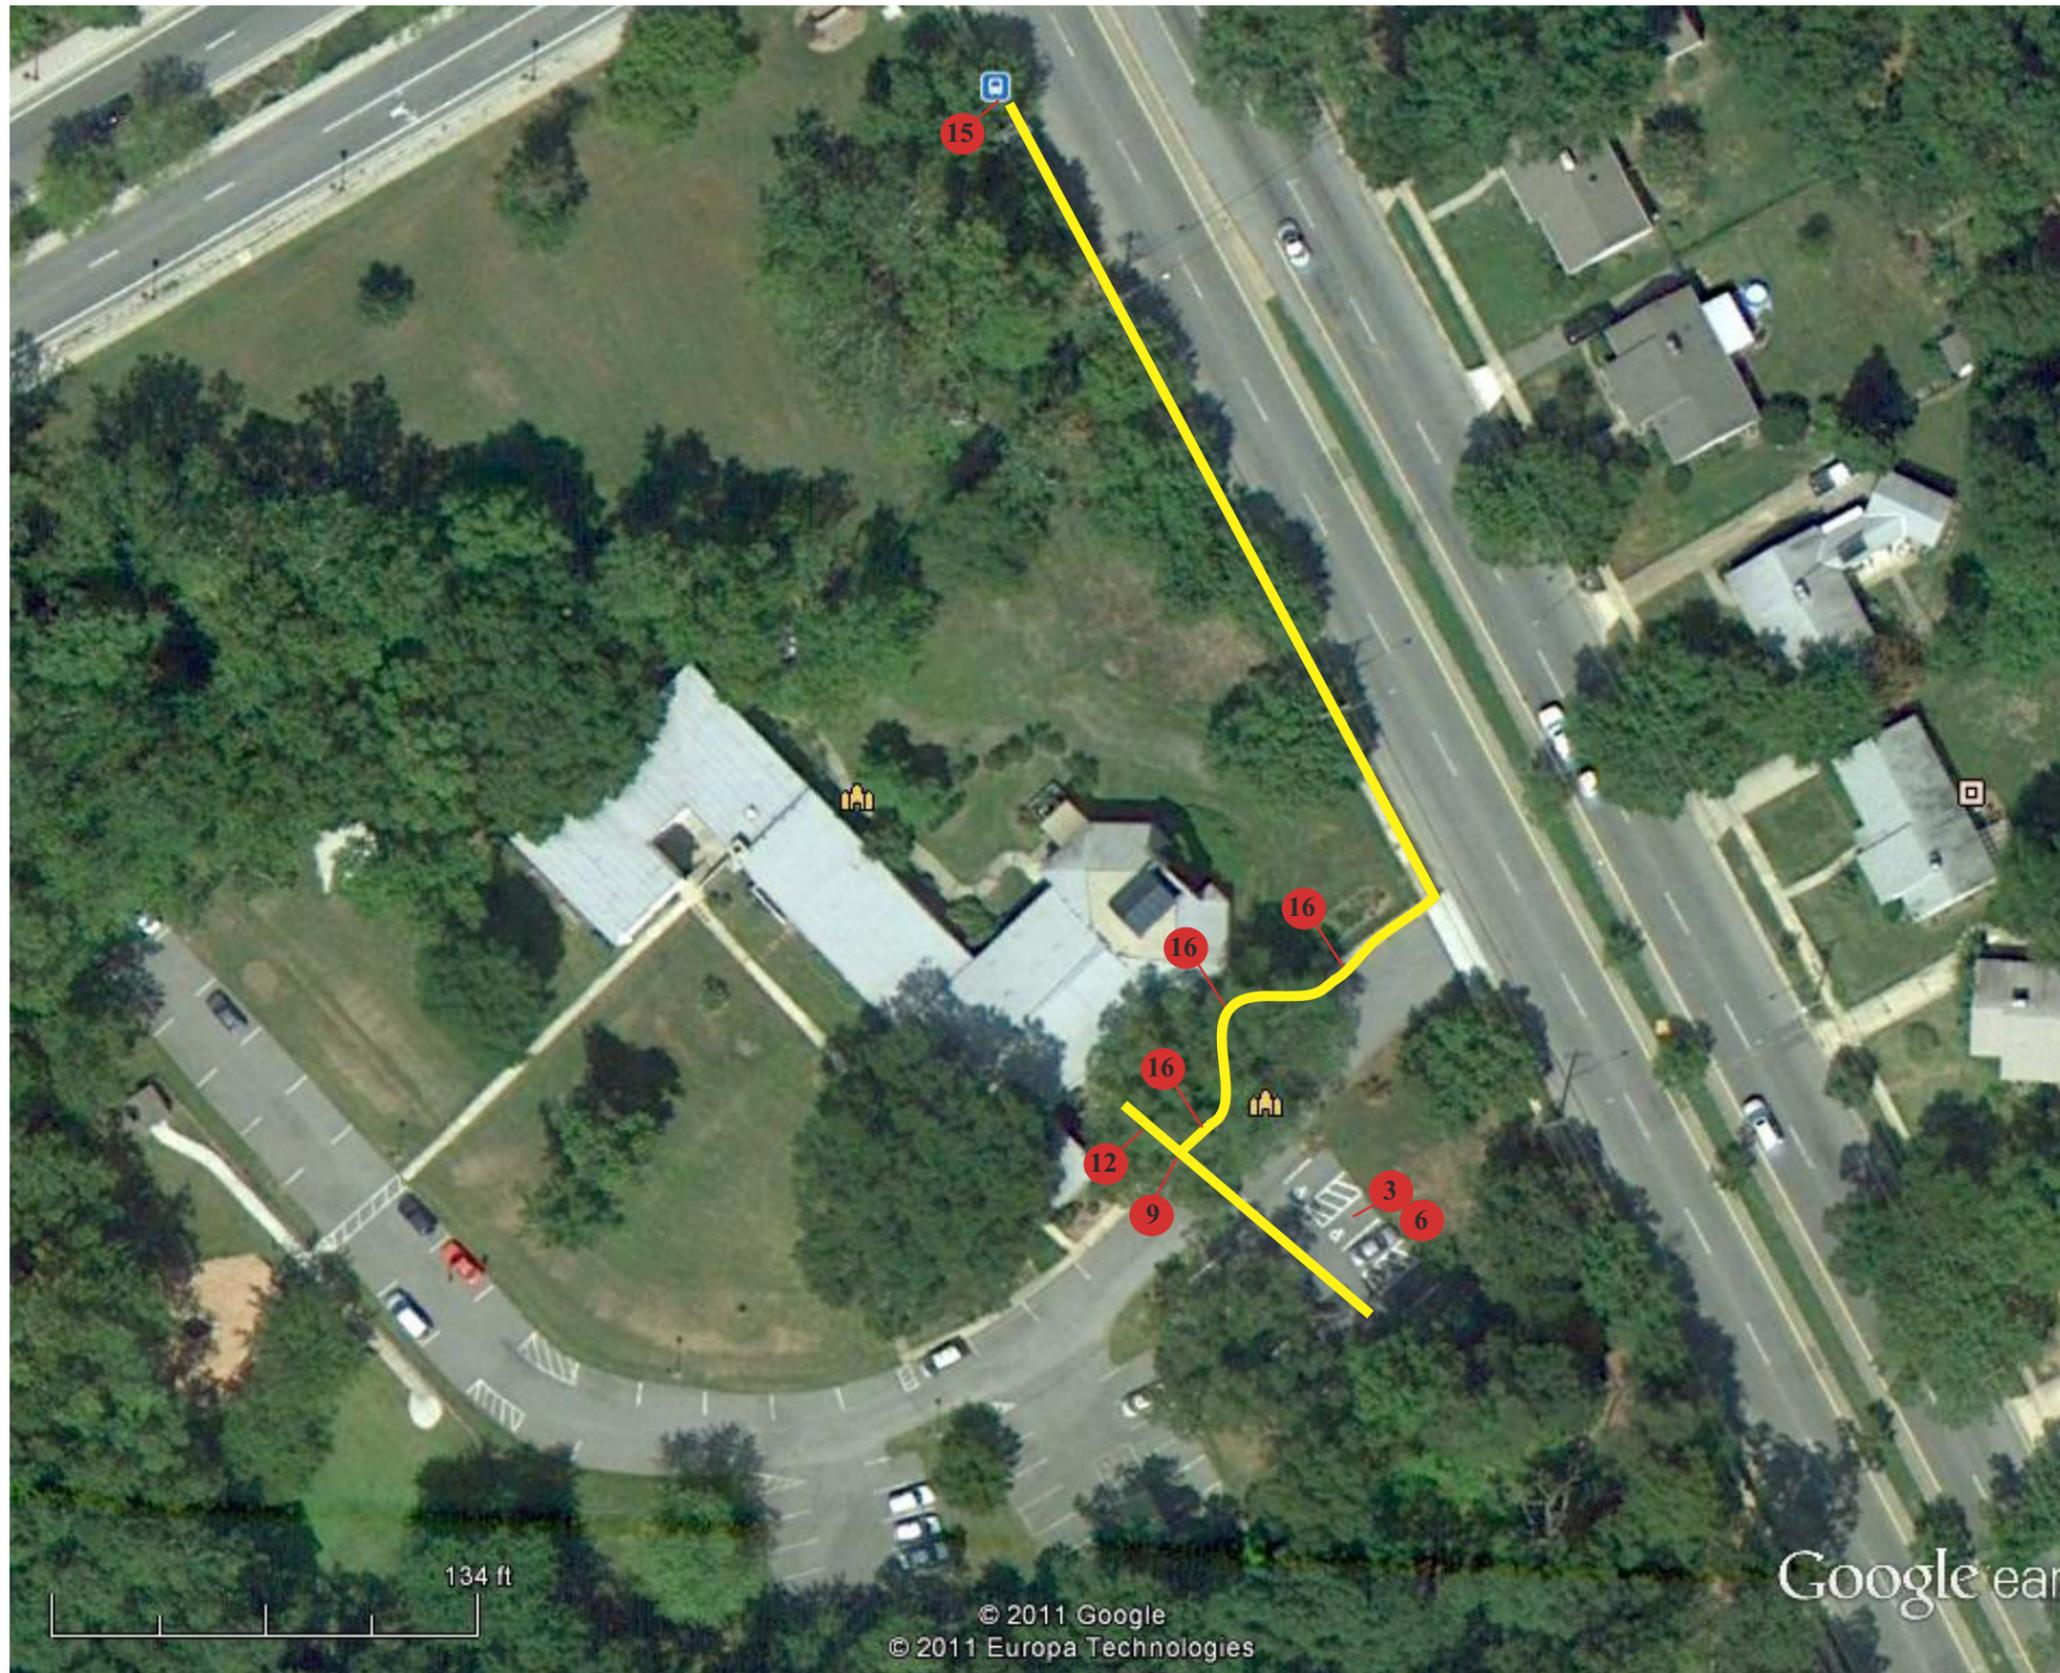
4	*208.2.4,	At least one van accessible parking space must be provided for every 8 accessible parking spaces.	Five (5) accessible spaces are provided. Therefore, at least one (1) must be van accessible. However, no van spaces are provided.		Corrected with solution for item 3	1		see item 3	\$0		
5	208.2, 502.2, 502.3.1	An accessible parking space must have an access aisle that is at least 60" wide.	At one of the accessible parking spaces the access aisle measured centerline to centerline is 56".	2838, 2839, 2840, 2841	Corrected with solution for item 3.	1		see item 3	\$0		
6	208.2, 502.6	Accessible parking signs must be visible over parked vehicles. It is acceptable to have the bottom of the sign at least 60" above the parking surface.	At all accessible spaces, the bottom of the five accessible parking signs are between 44" and 57" above the parking surface.	2842, 2843, 2844, 2845, 2846, 2847, 2848, 2849, 2850, 2851, 2852, 2853, 2854, 2855, 2856, 2857	Remount signs above 84" level.	6		\$800	\$800

7	206.1, 403.3	Accessible route cannot have a cross slope that is more than 2%.	A significant portion of the accessible route through the parking lot has a cross slope that ranges between 3.0% and 4.2%.	2930, 2931, 2934, 2935,	Corrected with solution for item 3	1		see item3	\$0		
8	206.1, 403.3	Accessible route cannot slope more than 8.33% and cannot slope more than 5% without having ramp features.	A significant portion of the accessible route through the parking lot has a slope that ranges between 6.0% and 13.4%.	2902, 2903, 2904, 2905	Corrected with solution for item 3	1		see item3	\$0

12	206.1, 403.3	Accessible route cannot have a cross slope that is more than 2%.	Along the exterior walkway near the entry door, the sidewalk has a cross slope that ranges between 4.2% and 5.9%.	2936, 2937, 2938, 2939	Rebuild sidewalk from curb ramp to entry door, with cross slopes no more than 2%.	1		\$3,960	\$3,960		
13	206.1, 303.4	Changes in level that are no more than 1/2" require a ramp, platform lift, or elevator.	At the building entry, along the accessible route between the sidewalk and the entry door, there is a change in level at a concrete joint, of more than 1/2", and is not ramped.	2942	Corrected with solution for item 12	1		See item 12	\$0		
14		Exterior Accessible Route from Bus Stop and Public Sidewalk to Building Entry/Voting Location :									
15	206.1, 403.3	Accessible route cannot have a cross slope that is more than 2%.	At the bus stop on Adelphi Road the sidewalk has a cross slope of 3.0%.	2980, 2981	Corrections are the responsibility of Maryland State Highway Administration (MSHA). Regrade and construct new concrete platform at bus stop with a maximum cross slope of 2%.	3	\$660		\$660

16	206.1, 403.3	Accessible route cannot have a cross slope that is more than 2%. Where the accessible route turns the cross slope is measured in two directions.	The accessible route between Adelphi Road and the building entry door has cross slopes between 8.1 and 8.5%.	2953, 2954, 2259, 2960	Regrade and reconstruct sidewalk with cross slopes no more than 2% and slopes no more than 5%.	1		\$4,840	\$4,840		
17	206.1, 403.3	Accessible route cannot slope more than 8.33% and cannot slope more than 5% without having ramp features.	The accessible route between Adelphi Road and the building entry door has a slope of 10% and does not have handrails.	2961, 2962	Corrected with solution for item 16	1		see item 16	\$0

2010 Standards Citation	Description/Issue/Requirement	Non-Complying Item	Photos	Proposed Solution	Suggested Priority	Projected Cost MSHA	Projected Cost Hyattsville	Projected Cost Total	Projected Date	Action and Date
18	206.1, 403.3	Accessible route cannot have a cross slope that is more than 2%. Where the accessible route turns the cross slope is measured in two directions.	At the front sidewalk leading to Adelphi Road, where the accessible route turns into the sidewalk around the tree, the cross slope is 3.8%.	2970, 2971	Corrected with solution for item 16	1		see item 16	\$0		
19	206.1, 303.4	Changes in level that are no more than 1/2" require a ramp, platform lift, or elevator.	Along the accessible route between the Adelphi Road and the entry door, there are changes in level at the concrete joints, of more than 1/2", that are not ramped.	2965, 2967, 2970, 2975	Corrected with solution for item 16	1		see item 16	\$0
