Hyattsville Accessibility Transition Plan

Centennial Memorial Park

Centennial Memorial Park - Hyattsville Transition Plan

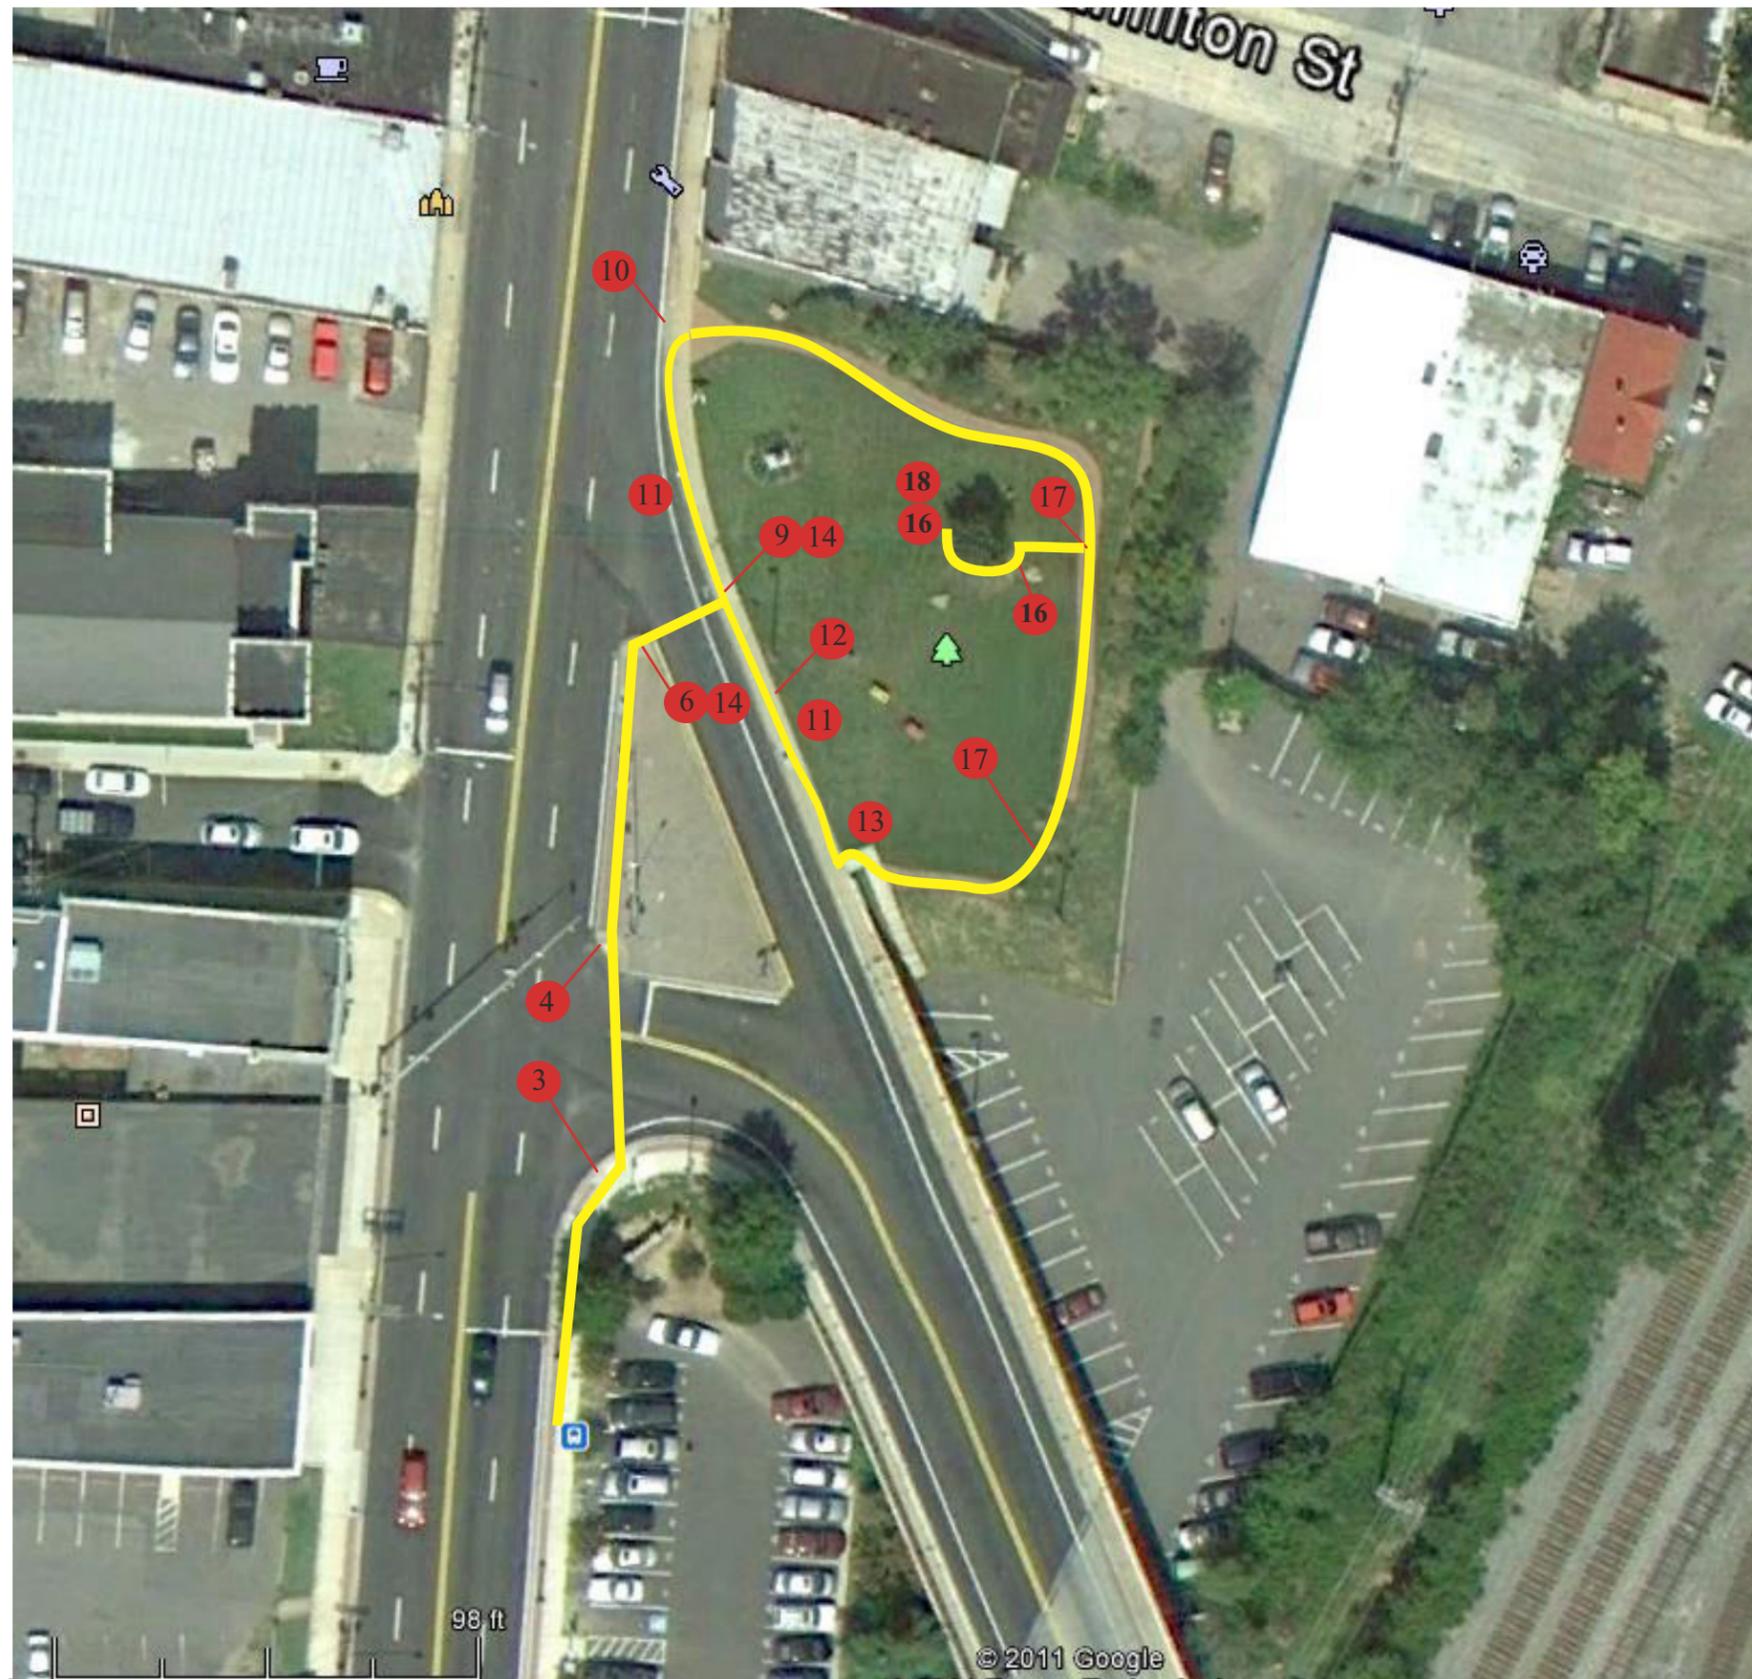
Proposed solutions
- see red item numbers
on the Transition Plan
spread sheets that
follow this page
