# Property Condition Report

## Hyattsville Administration Building

4310 Gallatin Street - Hyattsville, Maryland

July 7, 2011

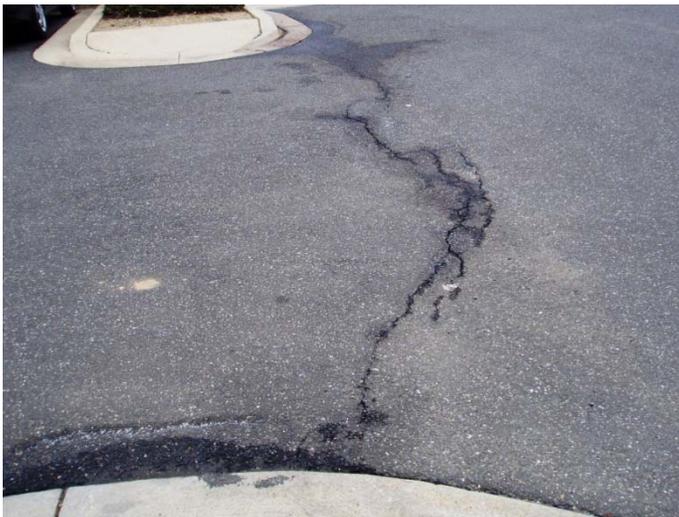
- Cracks have formed in the asphalt paving in two areas (Photographs 5 and 9). The open cracks allow water to collect below the wearing course and saturate the base course below it. In the winter, water will freeze and expand, widening the cracks and extending the damage. The cracks should be repaired as soon as possible to avoid expanding damage and a resulting escalation of repair cost.

**Photograph 5:** Cracked asphalt paving near the southwest corner of the building. The saturated asphalt in the area of the crack indicates that water is trapped in the asphalt. The crack should be sealed to stop the water penetration.

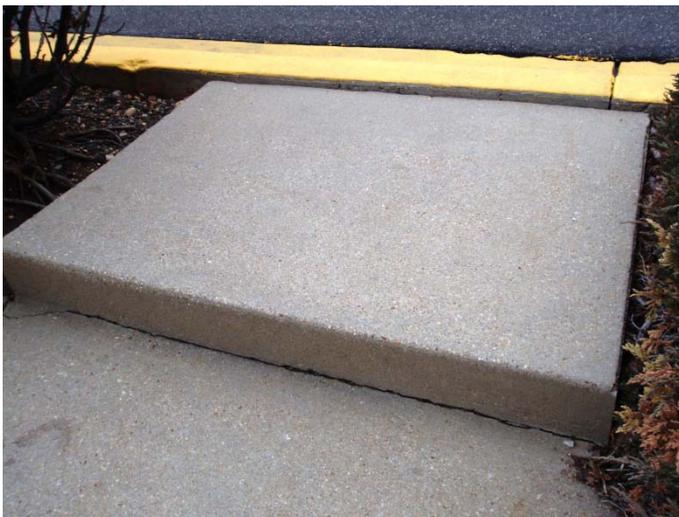
- A concrete walk abutting the curbing has settled near the southwest corner of the building, creating a potential tripping hazard to pedestrians (Photograph 6). The settled section of walk should be removed and replaced with new concrete, aligned with the top surface of the curb.

**Photograph 6:** The concrete walk has settled, creating an offset of 1-1/2" in the path of travel that present a tripping hazard to pedestrians. The settled concrete landing should be removed and replaced to eliminate the hazard.

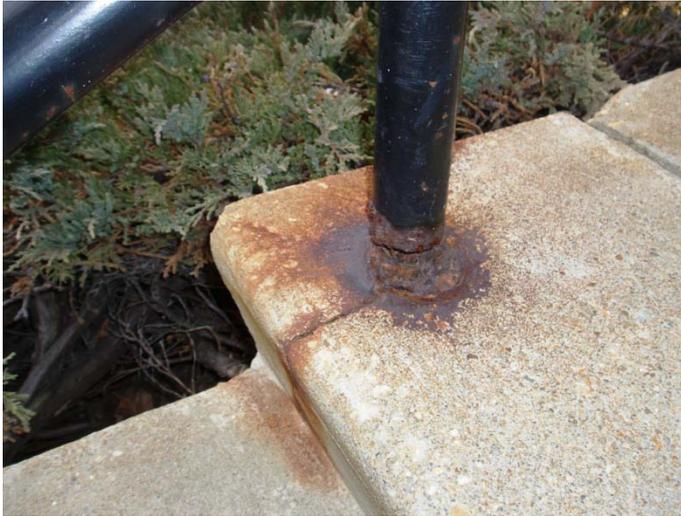
- Adjacent to the walkway and site stair at the west end of the building, the railposts are deteriorated where they were grouted into the concrete (Photograph 7). The guardrail on top of the retaining wall at the northeast corner of the site is also corroding at its post base (Photograph 8). The corrosion of the steel pipes has induced cracking in the surrounding concrete, and several of the railposts are severely weakened by the extent of deterioration. The railing should be removed and the damaged post bases repaired. Cracked concrete should be removed and replaced, and the railing re-installed. After the railposts are grouted into the concrete, the top surface of the grout should be sloped to shed water away from the grout pockets, so that water will not accumulate around the steel.

**Photograph 7:** Close-up view of a rusted railpost near the southwest corner of the building. The corrosion has significantly weakened the railpost and caused the concrete to crack, making the railing unstable.

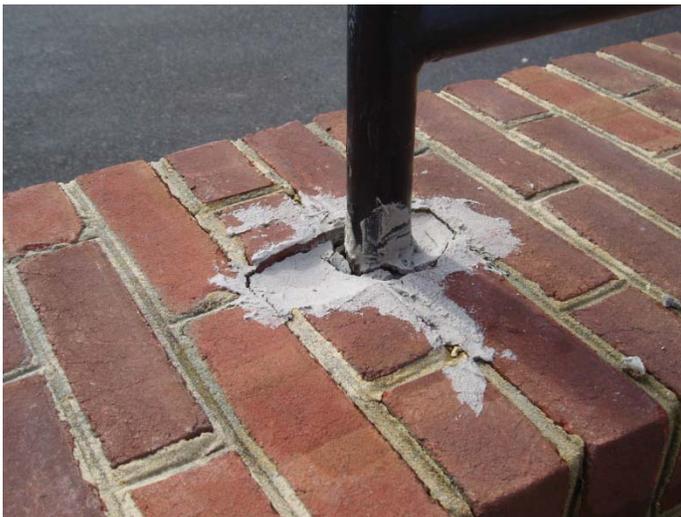
**Photograph 8:** Close-up view of a railpost mounted on the retaining wall at the northeast corner of the property. The depressed grout surface traps water around the steel post, causing it to corrode. The expansive forces generated by the corrosion of the steel have induced cracking in the surrounding grout and brick.

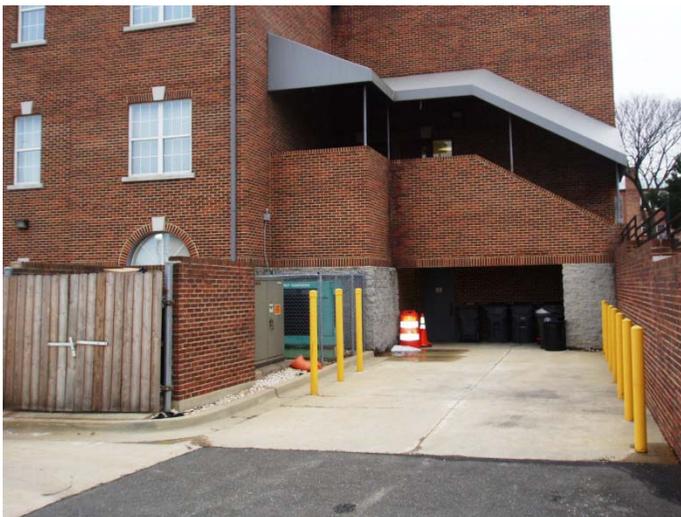
**Photograph 9:** The service entrance is on the east side of the building, below an exterior stair providing access to the second floor from the alley. The concrete and asphalt paving in this area have developed cracks in a few areas. The cracks should be sealed to prevent water seeping into the subgrade and expanding the deteriorated areas.

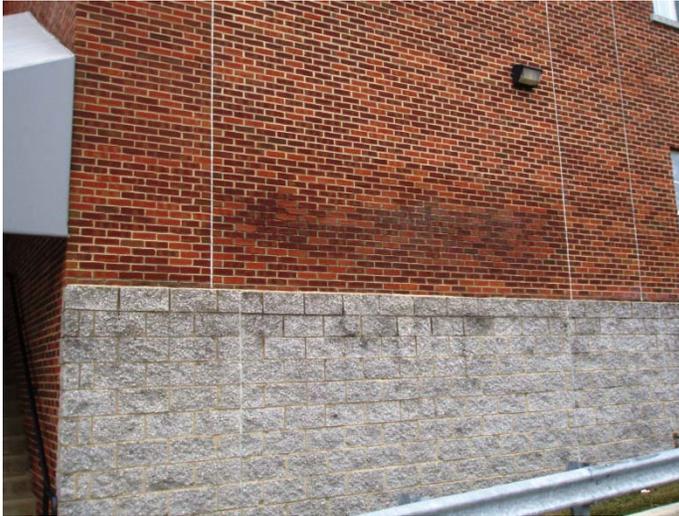
- Incipient cracking of the veneer was observed in a few areas, most significantly in the split-face CMU on the north wall (Photographs 10-13). The cracking has developed in the mortar joints between masonry units, most likely as a result of chronic saturation in the veneer. The split-face CMU terminates at the second floor level, and a grout wash was applied over the top surface to shed water to the exterior. The grout has broken away from the top of the veneer in many areas, exposing an open gap between the CMU and the brick. The gap has widened due to water accumulating in the veneer and freezing in this location.

**Photograph 10:** A section of the north wall, on the east wing of the building. The brick veneer is observable saturated, indicating that the cavity behind the veneer is not well drained via the flashing and weep holes located in the CMU below the brick. Saturation is also observable in the top of the split-faced CMU veneer at the base of the building.

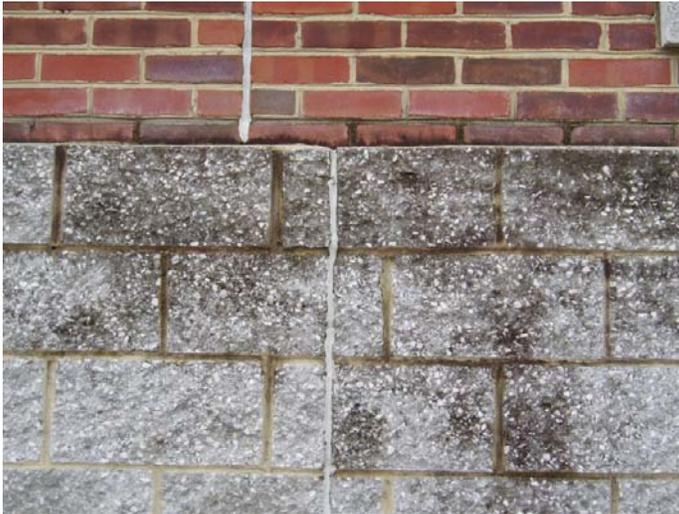
**Photograph 11:** Saturated CMU and brick veneer on north side of building, where algae is accumulating on the walls as a result of the chronic saturation.

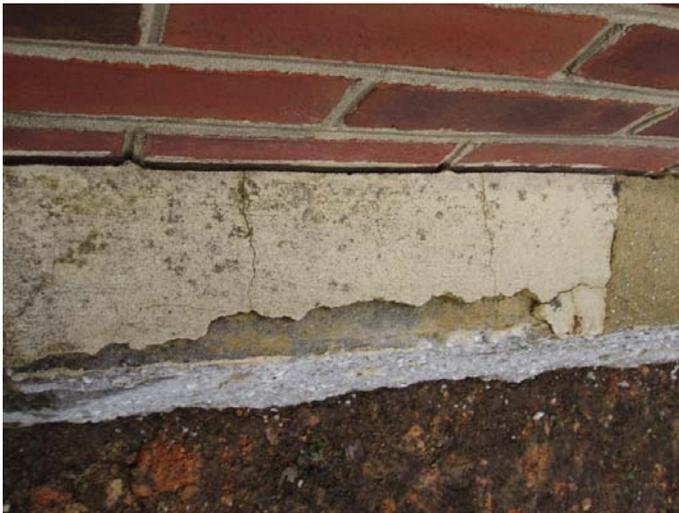
**Photograph 12:** Grout wash at the top of the CMU veneer is significantly deteriorated, exposing the non-sloped top of the CMU to standing water. An open gap between the CMU and the brick allows water to enter the exterior wall assembly at the first floor level, along the north side of the building.

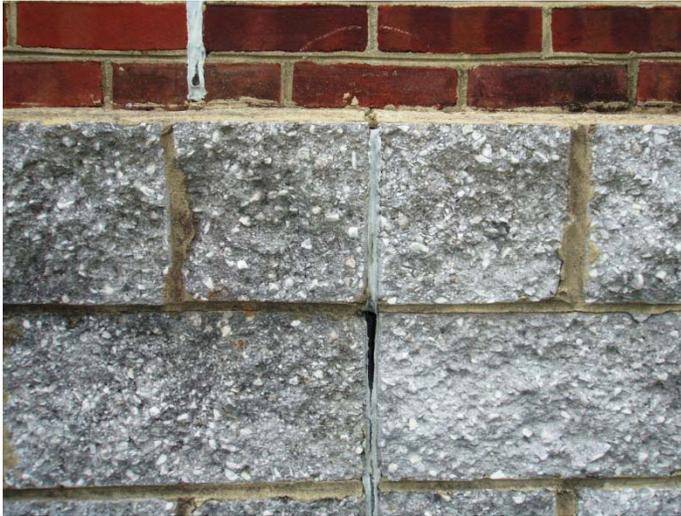
**Photograph 13:** The top course of CMU veneer has been laterally displaced along most of the length of the north façade, due to chronic saturation combined with freeze-thaw cycling. The bed-joint under the top course of masonry is cracked. Through-wall flashing was observed in two isolated areas, where the cracked mortar has fallen out of the joint and exposed the flashing. Repairs in this area will require the removal and re-installation of veneer.

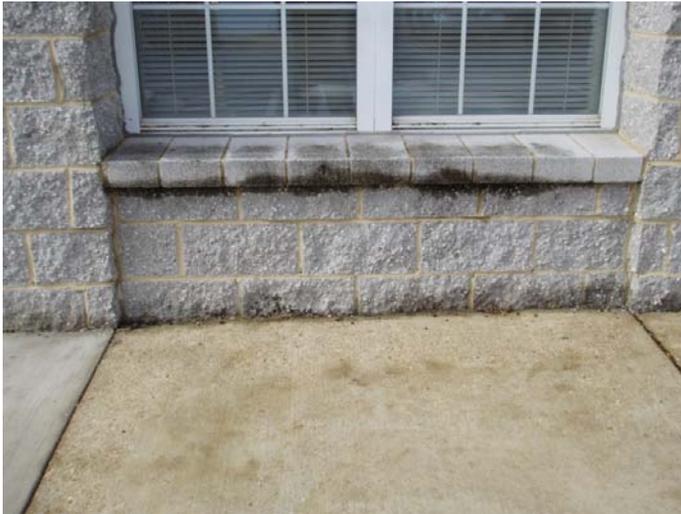
Other areas of the masonry show signs of weathering, chronic saturation, and incipient cracking (Photographs 14-19). Each of these areas should be inspected closely by a qualified masonry repair contractor, and appropriate repairs should be made promptly to avoid an acceleration of the damage and resulting escalation in repair costs.

**Photograph 14:** Discolored CMU at a sill on the east end of the building.

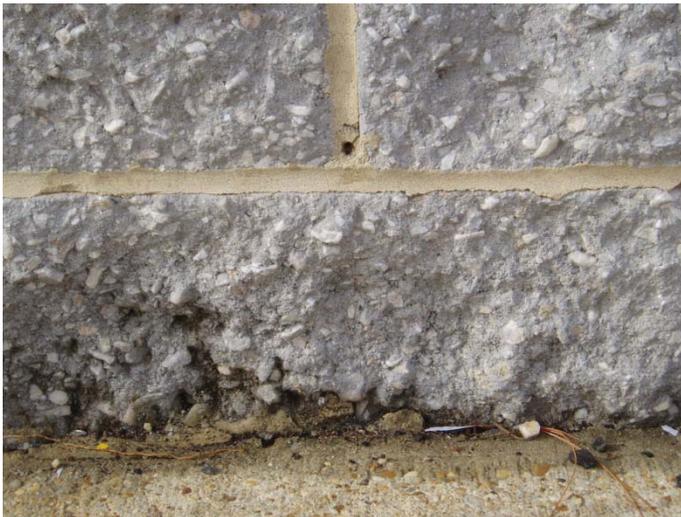
**Photograph 15:** Close-up view of a “weep hole” in the veneer below the sill shown in the preceding photograph. The small weep holes are inadequate to drain moisture accumulating in the cavity behind the veneer. Susceptible to plugging, the holes also are placed above the through-wall flashings that were installed to capture and direct moisture to the exterior. The staining on the masonry at the bottom of the wall is an indication of insufficient drainage of the veneer cavity.

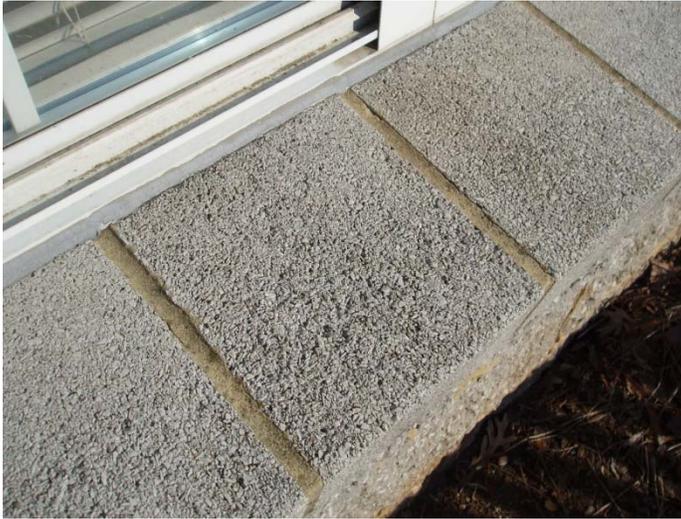
**Photograph 16:** Close-up view of a CMU sill on the south front of the building. The surface of the masonry is weathering from exposure to rainfall.

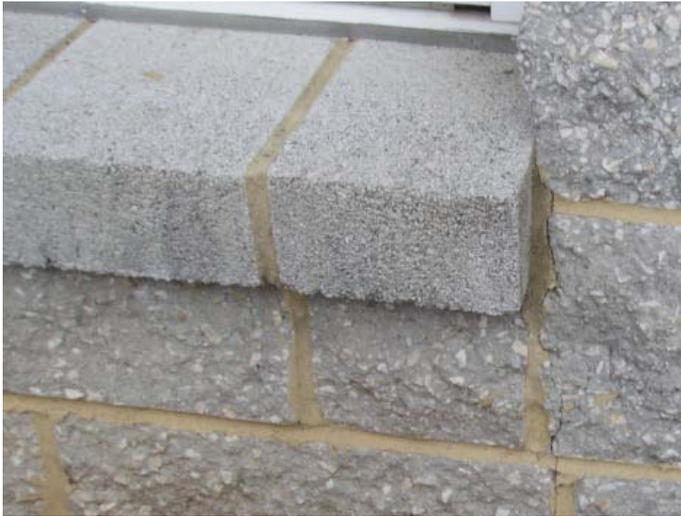
**Photograph 17:** Cracked CMU veneer below a sill on the south front of the building.

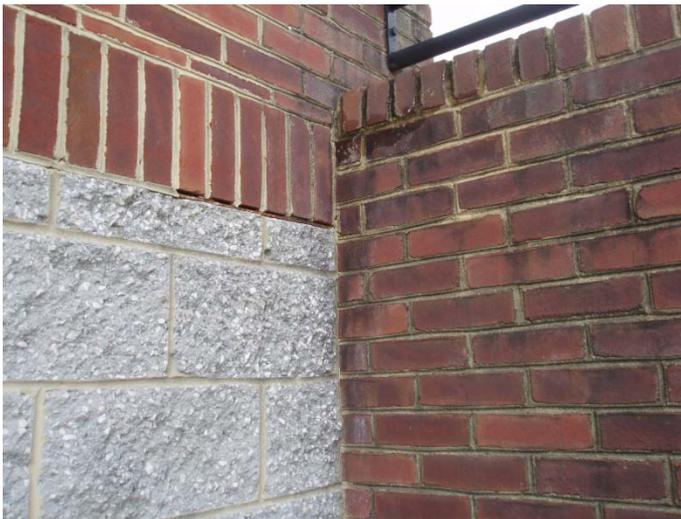
**Photograph 18:** The masonry is saturated where a brick retaining wall abuts the northeast corner of the building.

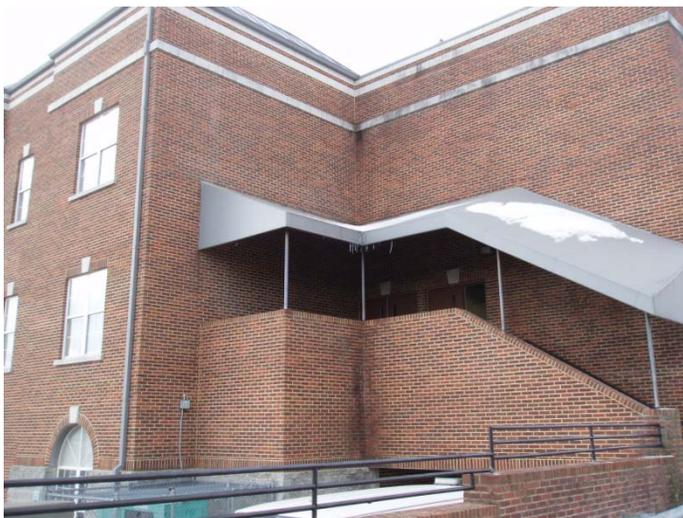
**Photograph 19:** Stained masonry was observed above and below the canopy over the east entrance to the second floor of the building.

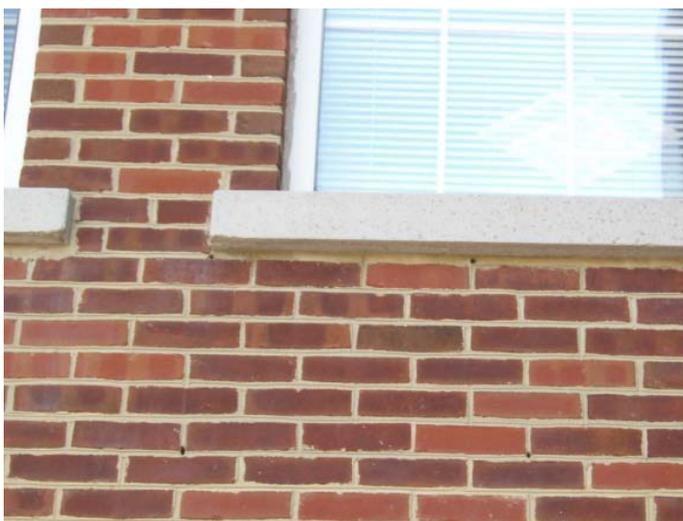
The deterioration of the veneer may be exacerbated by the construction details used when it was installed. The small weep holes appear to have been made with a screwdriver or similar tool after the veneer was installed (Photograph 20). Located above the flashings that are presumed to exist in the veneer, they will tend to trap water in the brick. At other locations, weep holes are not present where the drawings called for them to be installed (Photographs 21 and 22).

**Photograph 20:** Typical view of the brick veneer, showing small weep holes placed below the cast stone sill and at the second floor level, six courses below the sill. The holes are most likely placed above the through-wall flashings, trapping water in the veneer.

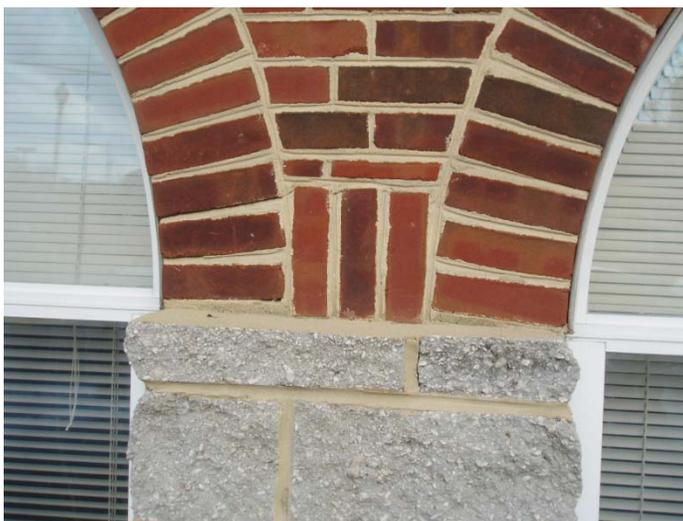
**Photograph 21:** No weep holes are present at the base of the brick veneer, where the brick bears on the split-face CMU. The original construction drawings call for through-wall flashing and weep holes along the bottom edge of the brick.

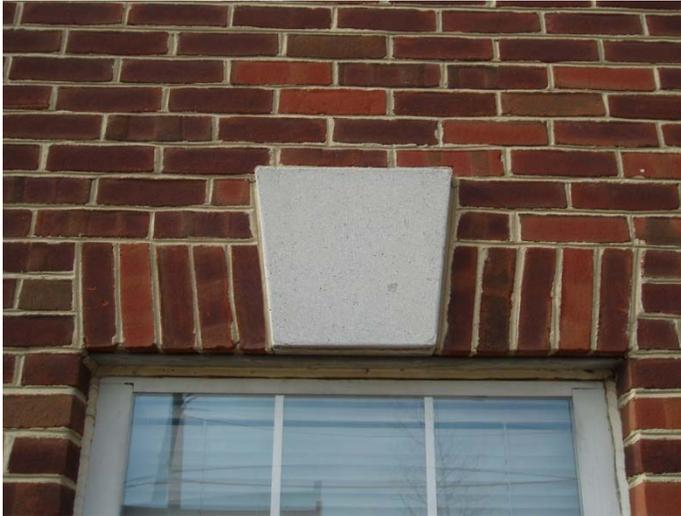
**Photograph 22:** No flashing and weep holes were observed above the steel lintel supporting masonry over the window opening.

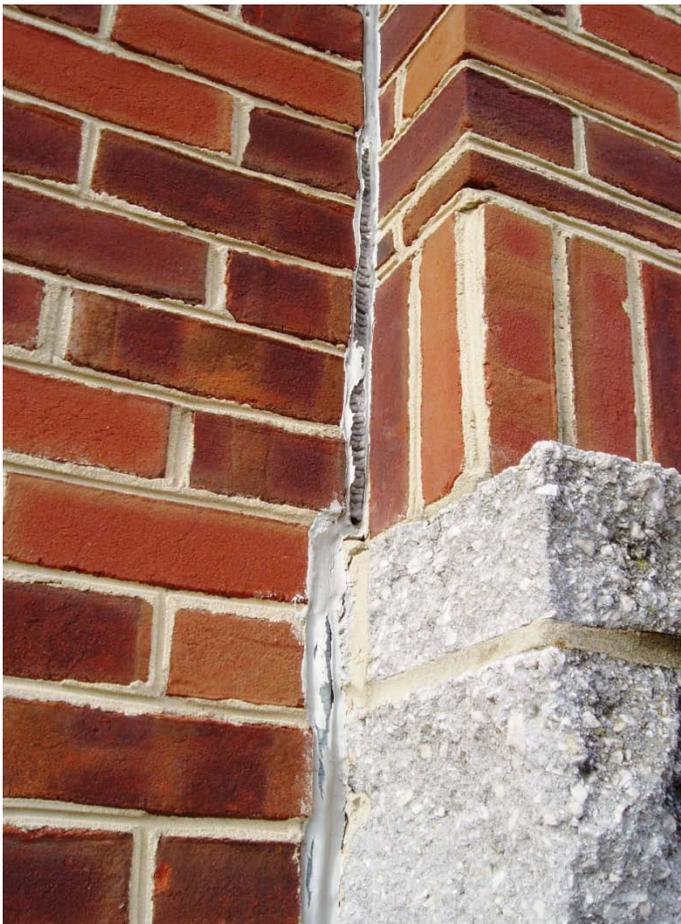
- The sealant has experienced cohesive failure in nearly all of the masonry veneer control joints (Photograph 23). A majority of joint failures appear to be due to the sealant having been insufficiently thick to resist tearing. The existing joint should be cleaned of sealant and backing material, and new backer rod and sealant should be placed and tooled into the joints. Care should be taken to assure the sealant depth is one half of the joint width, in accordance with ASTM standards. It is recommended that a one-part neutral-cure silicone sealant is used to re-seal the control joints.

**Photograph 23:** The sealant has ruptured in the veneer control joint, exposing the wall to water and air infiltration. The original sealant and backing should be removed and the sides of the joint cleaned to promote adhesion of new sealant, before the joints are re-sealed.

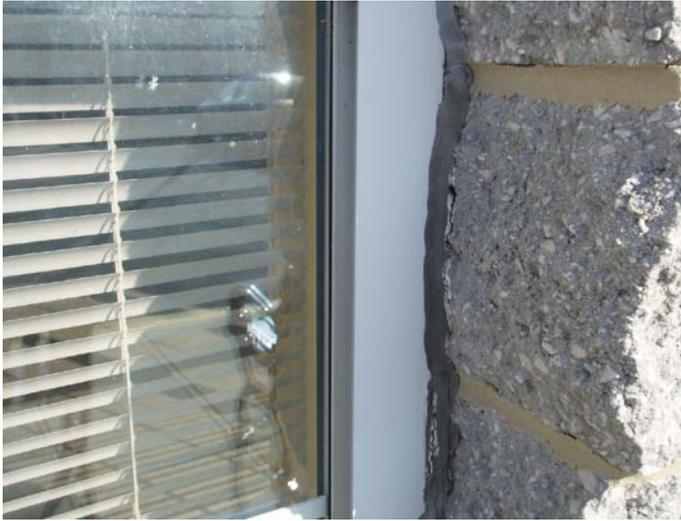
- The window perimeter sealant has failed in many areas (Photograph 24 and 25). The existing sealant appears to have become brittle over time, indicating that a butyl rubber material may have been used. The cove joint configuration can lead to sealant rupturing in locations where there is insufficient space between the metal frame and the masonry to accommodate differential movement. The new sealant applied at these joints should be applied over a bond breaker applied into the back of the joint. The silicone sealant recommended for use at control joints is appropriate for use at window perimeters as well.

**Photograph 24:** The sealant applied at the window perimeters shows signs of incipient adhesion failure. The material also has become brittle, suggesting that a non-UV-resistant material was used in the original construction. New sealant used to seal the window perimeters and control joints should be polyurethane.

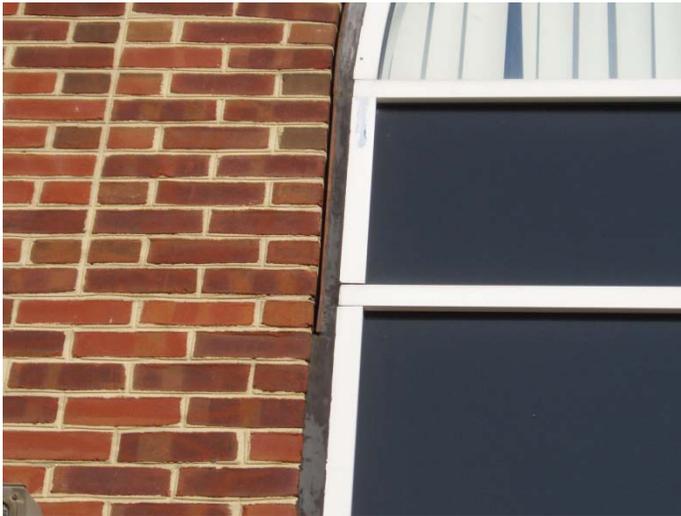
**Photograph 25:** The joint between the brick veneer and the storefront system has opened to air and moisture, due to adhesive sealant failure at the masonry.

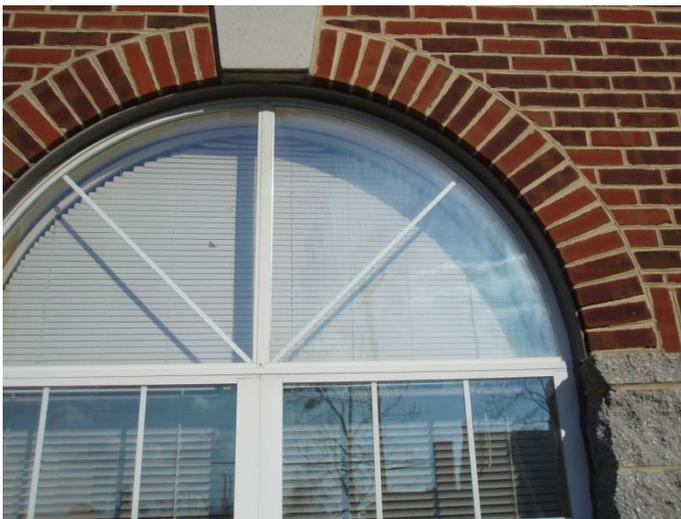
The glazing seals have ruptured on most of the half-round transom lights, due to chronic saturation of the glazing edge within the frame (Photograph 26). The lack of thermally broken sash frames increases heat loss by allowing the efficient conduction of cold winter temperatures into the building; conductive drafts and air infiltration were observed during the inspection. The lack of thermal breaks and weeps in the frames, combined with the tendency of the existing windows to deflect excessively under wind loading, allow water to accumulate in the sash frames, causing the glazing seals to be chronically saturated. Chronic saturation of the glazing seal causes the material to fail prematurely; the ruptured seals lead to condensation within the insulated glass panes.

**Photograph 26:** View of a typical half-round transom window above a pair of single-hung windows. The aluminum windows are glazed with  $\frac{3}{4}$ " insulated glass panes that have been fitted with decorative aluminum grilles to simulate muntins. Condensed moisture is visible in the transom light, indicating a failure of the glazing seal. This condition was observed at nearly all of the transoms on the building.

The existing windows are not compliant with currently accepted design standards for office buildings; window units with an AAMA rating of HC-60 are generally used in three-story commercial buildings. It is recommended that the windows throughout the building be removed and replaced to improve the thermal efficiency and weather-tightness of the exterior envelope. The new windows should be designed and fabricated to comply with AAMA specifications for HC-60 windows. All frames and sashes should be manufactured with a thermal break.

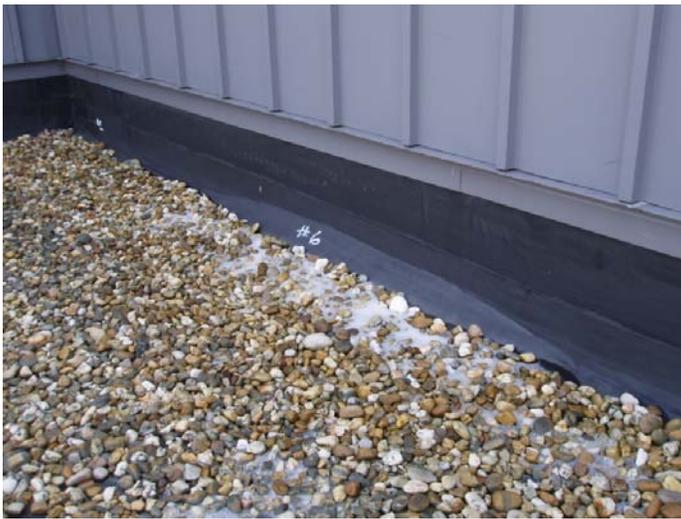
- The baseflashings have failed in adhesion to the parapet walls and jump walls at numerous areas (Photographs 28 and 29). The baseflashings have been repaired in many areas. The adhesion failure is a result of shrinkage in the membrane, which occurs as a result of prolonged exposure to ultraviolet radiation, a component of sunlight. UV exposure will also produce long term reduction in tensile strength and increased brittleness of EPDM membranes. Roofs of this type have a normal useful service life of 15 to 20 years. Due to the age, type and condition of the existing roofing system, it is recommended that the roofing membrane be removed and replaced.

**Photograph 28:** The EPDM baseflashing has shrunk and pulled away from the basewalls at the roof perimeter, due to long-term exposure to UV radiation. The membrane bridges a gap between the roof and wall surfaces. Where it is not backed up by solid material, the single ply roof membrane is vulnerable to damage that will allow water to breach the roofing system and enter the building.

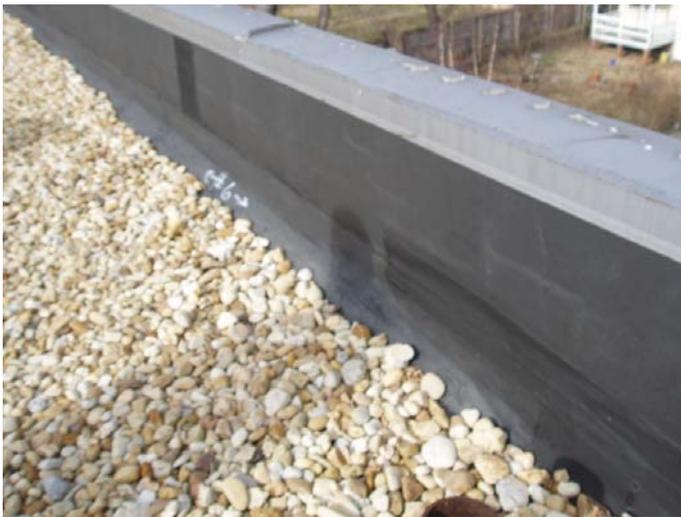
**Photograph 29:** Another view of roof baseflashing failure, at a location along the north parapet wall.

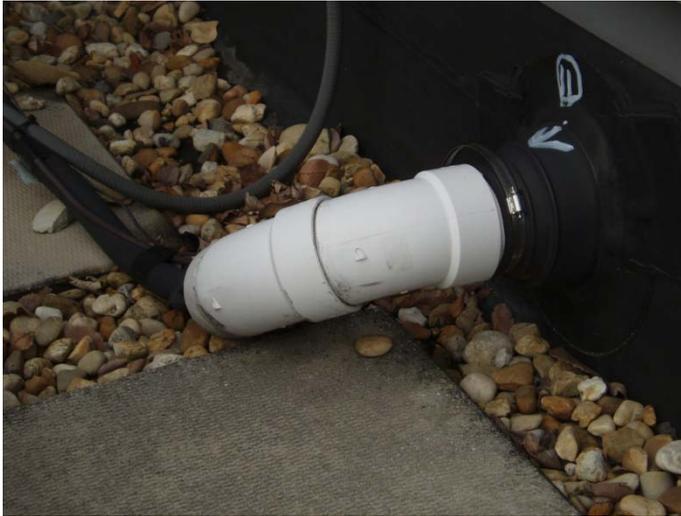
- A penetration was made in the baseflashing approximately three inches above the roof surface, when the split system air conditioner was installed for the server room in the northwest corner of the building (Photograph 30). The PVC pipe that passes through the jump wall at this location is vulnerable to water intrusion, due to its limited elevation above the

**Photograph 30:** The condensate lines and control wiring for the air conditioner on the roof pass through an opening in the baseflashing that is approximately 4" above the roof surface. The pipe penetration is vulnerable to water entry in cases of drifting and melting snow. This roof penetration should be revised when the roofing system is replaced.

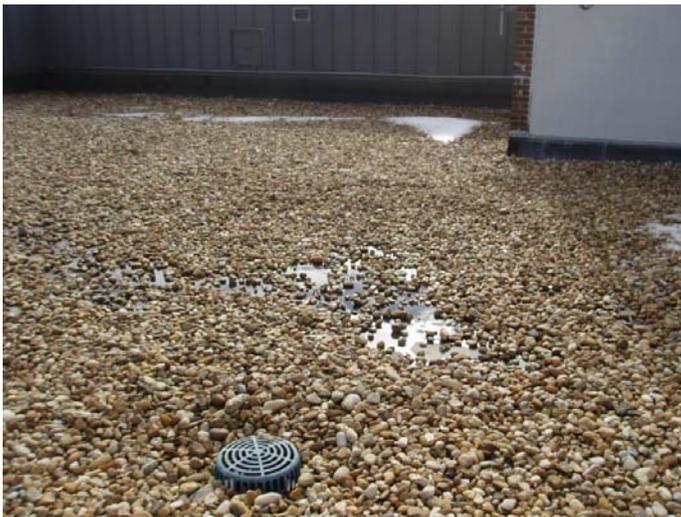
**Photograph 31:** The low-slope roof was designed to slope to pipe internal drains. An area of "ponding" water is visible in this photograph, located several feet away from the drain. Chronic exposure to standing water can cause seams in membrane roofing to fail prematurely.

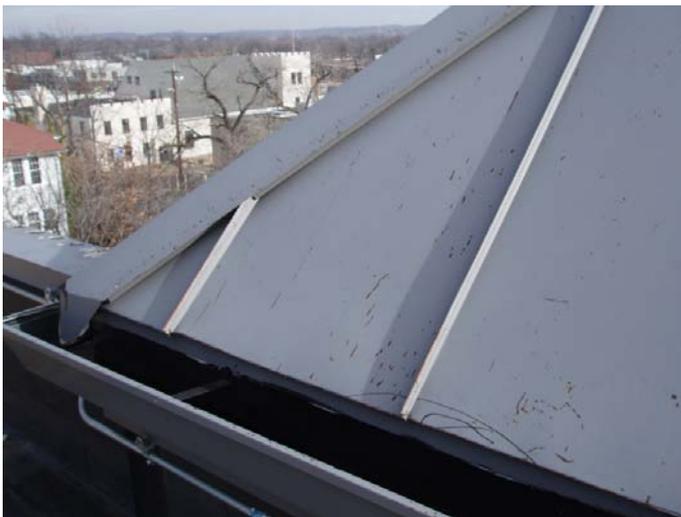
**Photograph 32:** A view of the sloped mansard roofing, where the mansard returns at the east end of the building. The enamel finish has been damaged, and the exposed steel is corroding. The roofing should be repainted in such areas, to stop the corrosive deterioration of the sheet metal.

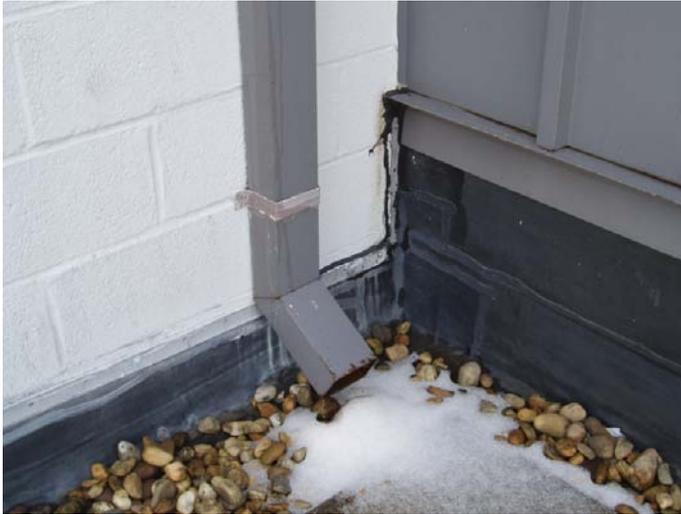
**Photograph 33:** A metal downspout drains water from the mansard eave onto the low-slope roof approximately three feet below. Ice and debris can accumulate in these gutters, damaging them and potentially leading to “ice dams” and water intrusion. Gutters at the roof eaves facing the low-slope roof should be removed.

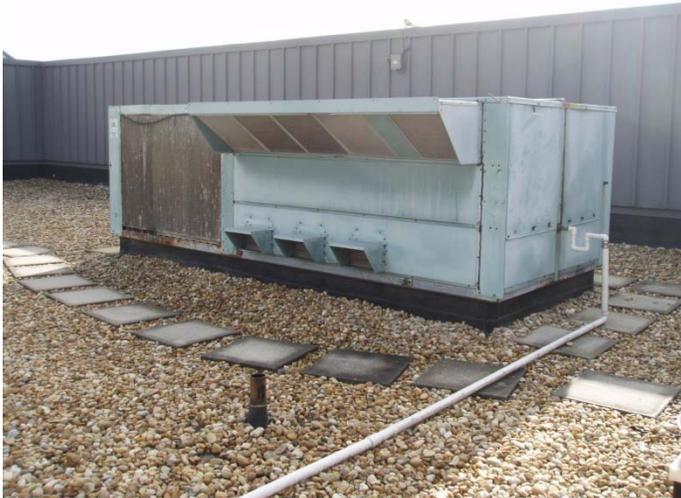
**Photograph 34:** HVAC – Variable air Volume Package Cooling Only Rooftop Unit, the unit has surpassed its life expectancy

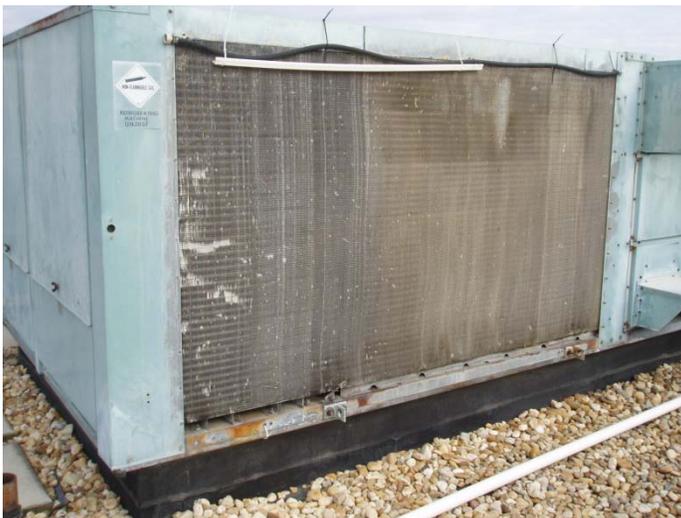
**Photograph 35:** Damaged condenser coils on Variable air Volume Package Cooling Only Rooftop Unit. The unit has surpassed its life expectancy and the damage coils has decreased its efficiency.

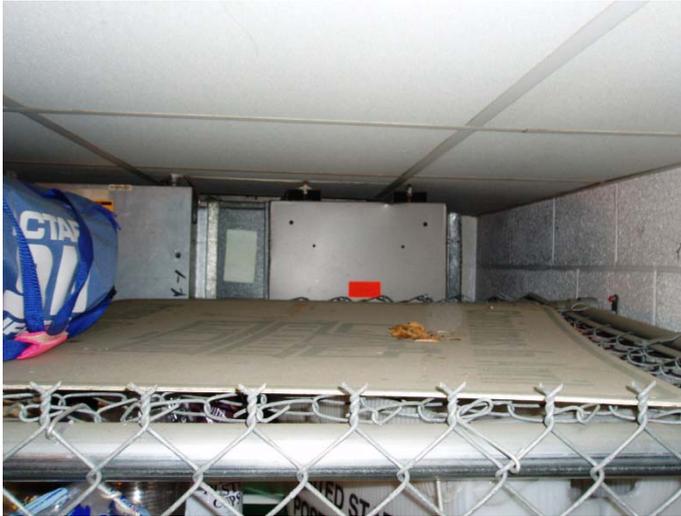
**Photograph 39:** View of a unit heater above a storage area in the southeast corner of the garage. The contents of the caged storage area block air distribution to and from the unit heater as well as a louvered opening in the exterior wall, through which fresh air is intended to enter the space and provide the required ventilation.

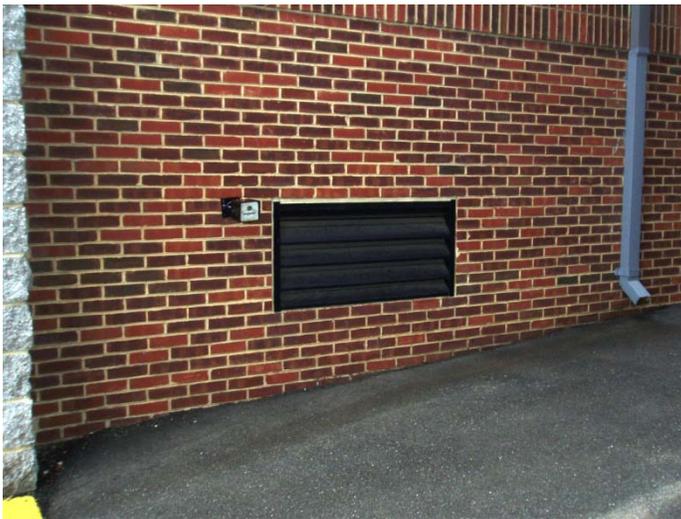
**Photograph 40:** View of the fresh air intake that is blocked by the storage area referenced in the preceding photo.

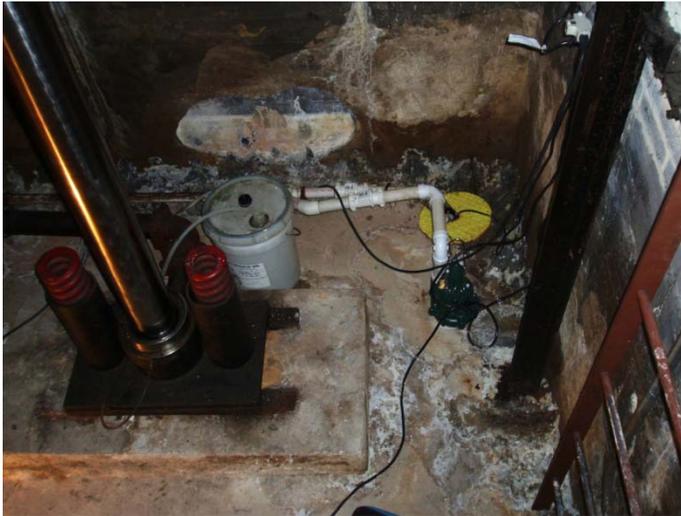
**Photograph 43:** View of elevator pit after a pump was used to evacuate water. Guide rail, piston and buffer bases were examined and light rust formation was observed, indicating repeated water entry. Installation of pit drainage and waterproofing was in progress at the time of the inspection.

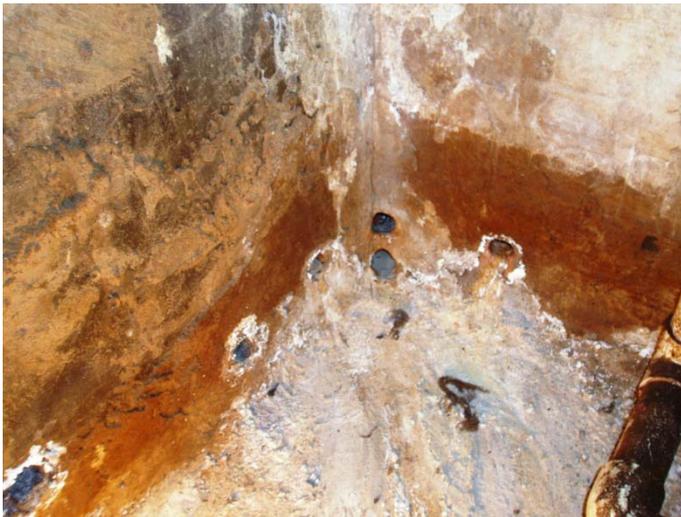
**Photograph 44:** Close-up view of holes drilled through elevator pit walls. The holes were reportedly drilled to allow water to enter the pit. The waterproofing to be installed will reportedly consist of a structural wall panel set inside the original pit walls, limiting water entry to the space between the original pit walls and the new wall panels. The sump pump will evacuate water from this annular space.

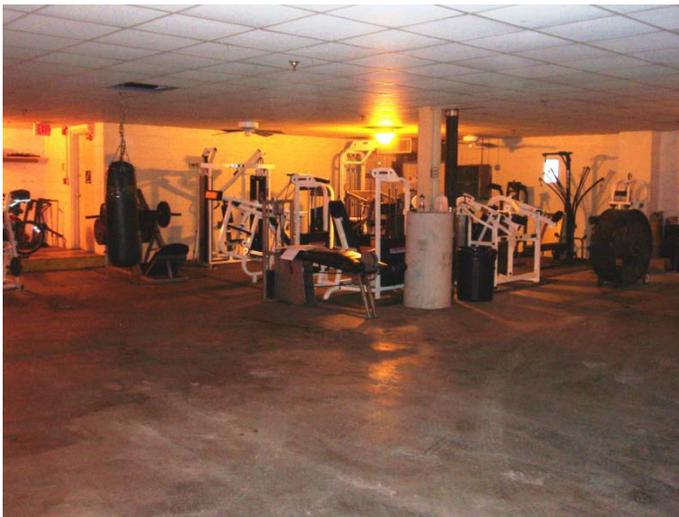
**Photograph 46:** Exercise equipment is installed in an open portion of the garage, and in a space enclosed by CMU walls. The workout areas occupy four parking spaces, two of them now enclosed by the CMU walls. The ventilation of this space does not meet code requirements for enclosed parking. The occupancy of the garage by an exercise/workout use is also in violation of code requirements.

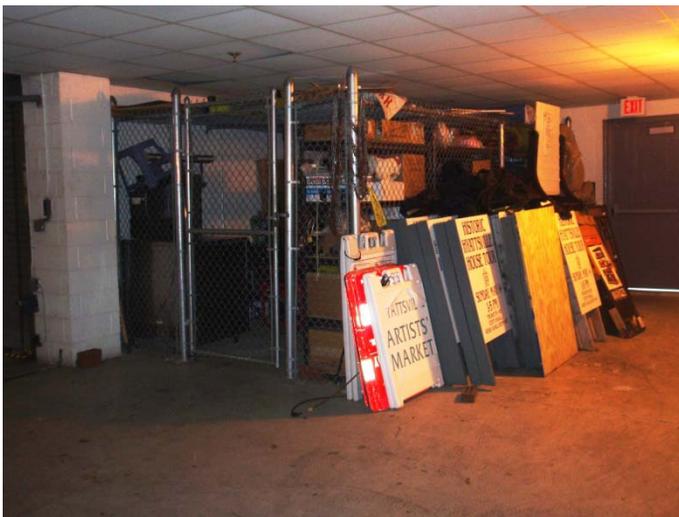
**Photograph 47:** A view of the enclosed storage area that blocks air movement at the fresh air intake and one of the space heaters that serve the garage space.

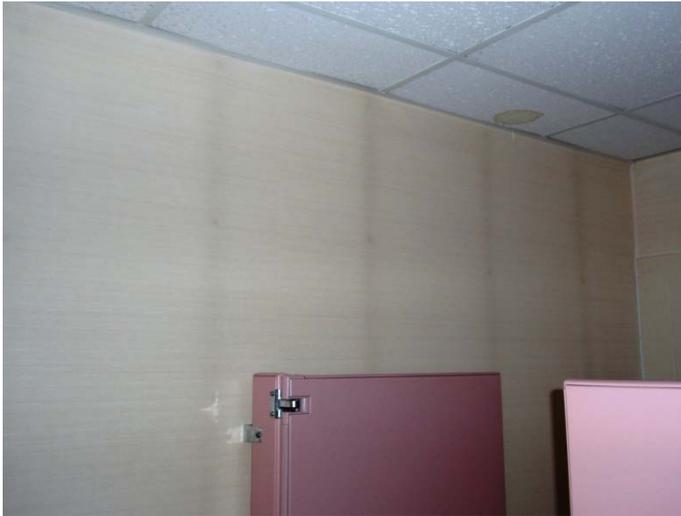
Stained gypsum wallboard on the walls of the public toilet rooms indicate potential saturation, which may be a result of uncontrolled condensation on the back of the vinyl wallcovering. Exploratory openings should be made to inspect the exterior face of gypsum board and verify the presence of moisture. The un-faced glass fiber insulation in the ceiling plenums above the public toilet rooms is a code violation, and must be removed immediately. Both conditions indicate problems with the thermal and vapor barriers on the exterior wall in this section of the building.

**Photograph 49:** The interior face of the women's room on the second floor is stained in vertical strips that most likely correspond to the stud locations. Darker spots are visible in the photograph, probably caused by rusting screws behind the vinyl wallcovering. This condition, caused by chronic condensation of moisture on the stud surfaces, was observed in the public toilet rooms on the second and third floors.

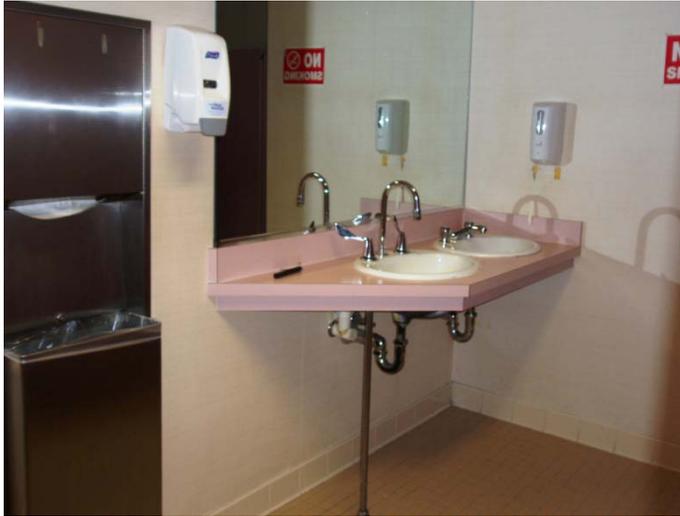
**Photograph 51:** Women's toilet room on the third floor. No protection is in place on the piping below the lavatories, as required by the ADA Accessibility Guidelines.

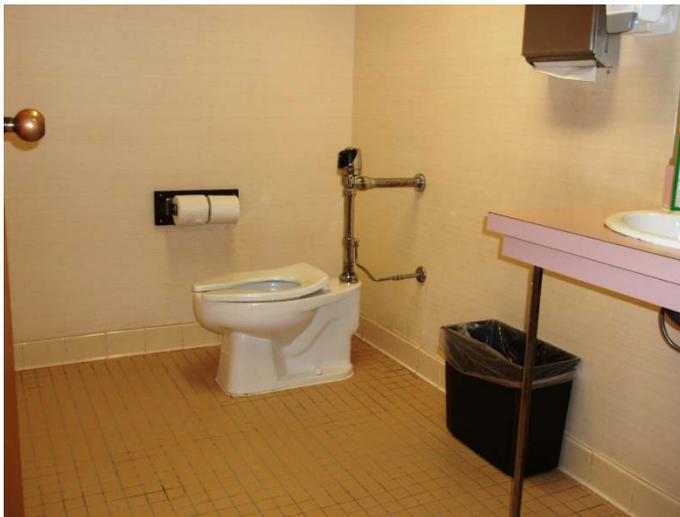
**Photograph 52:** One of two toilet rooms serving the administrative offices on the third floor. No grab bars were installed on the walls beside and behind the toilets, as required by ADAAG and as shown on the original drawings.

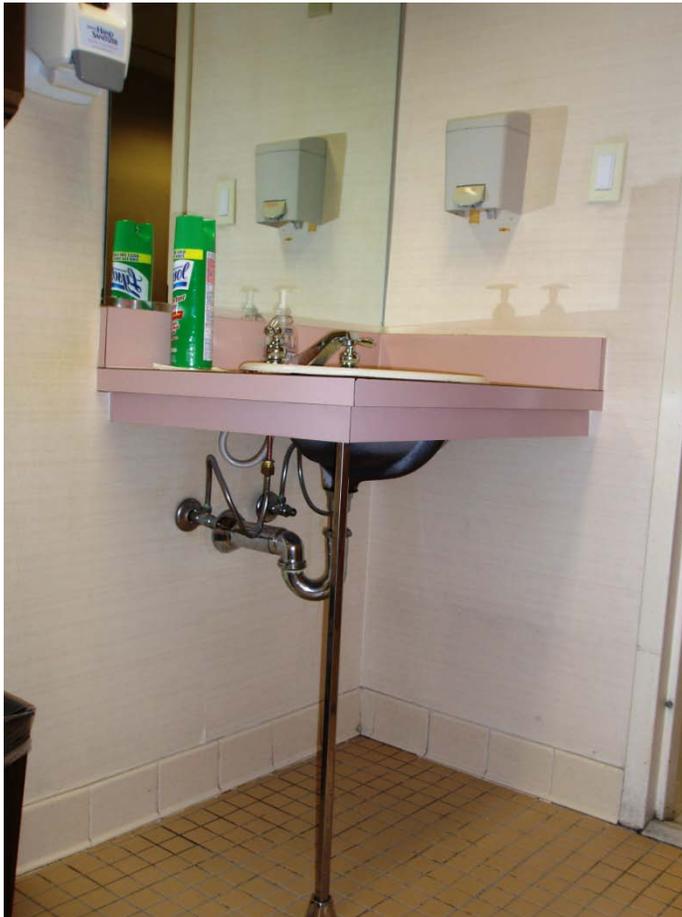
**Photograph 53:** Lavatory in the men's toilet room service the administrative offices. No protection is installed on the piping.
