# Property Condition Report

## Hyattsville Administration Building

4310 Gallatin Street - Hyattsville, Maryland

July 7, 2011

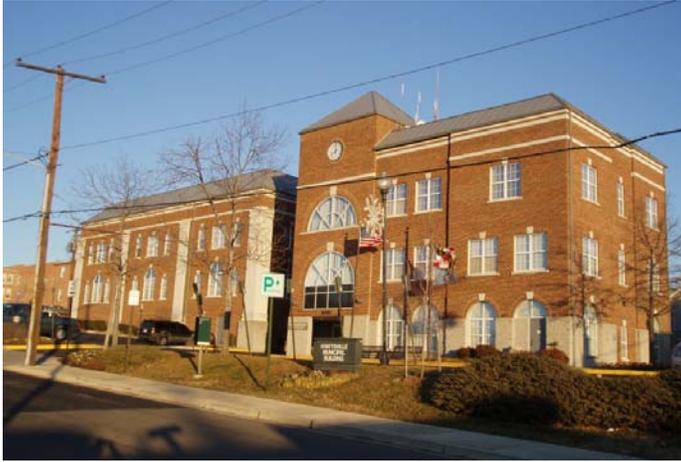
The property slopes significantly from the northwest corner of the site toward the southeast corner (Photograph 1). The slope is substantial enough that there are no areas where water could collect on the site. The north wall of the building, and the retaining wall that extends from the northeast corner, effectively block the flow of stormwater onto the site from adjacent properties.

**Photograph 1:** Front facade.

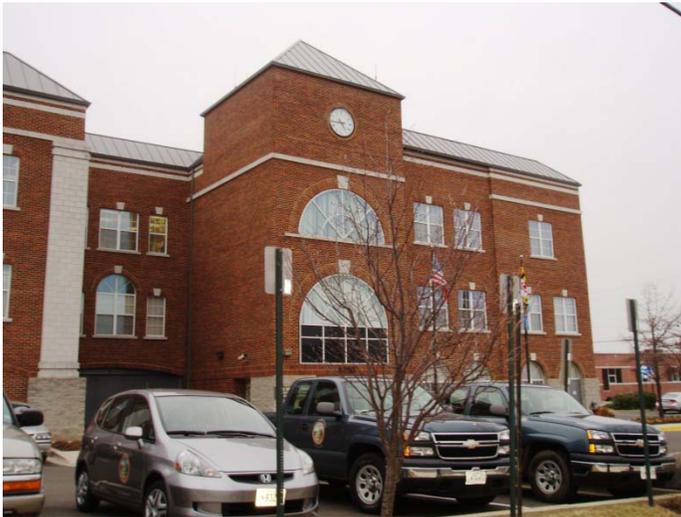
**Photograph 2:** The east wing of the building, with the clock tower above the main entrance, houses meeting spaces on each floor.

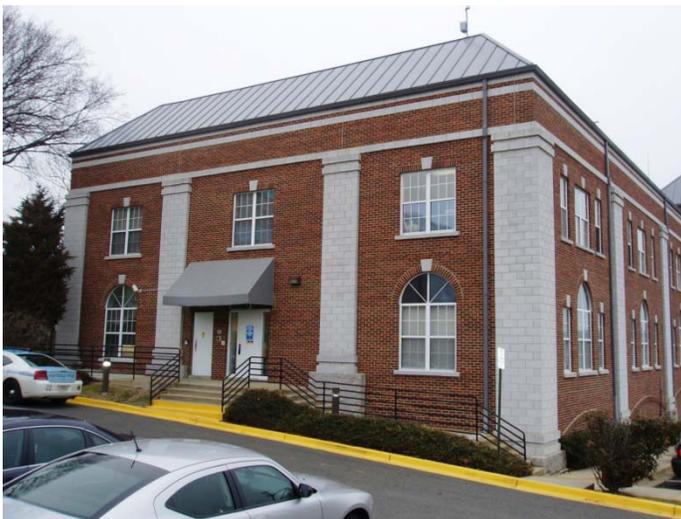
**Photograph 3:** The west wing of the building contains offices on two floors, above enclosed vehicular parking on the first floor level. A secondary entrance at the second floor level is located on the west end of the building.

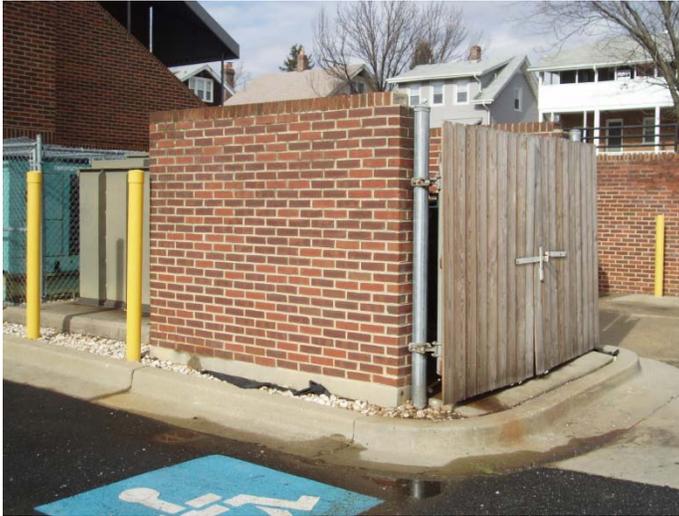
**Photograph 4:** Brick masonry walls enclose a dumpster next to the loading dock on the east end of the building.

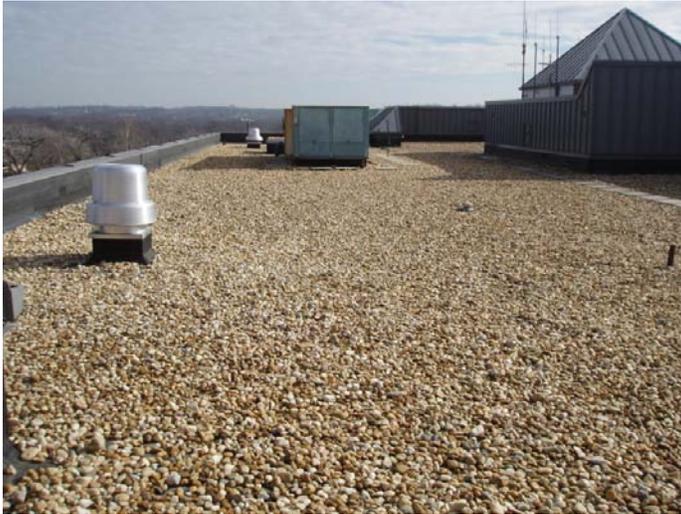
The existing low-slope roof has exceeded its service life and displays ongoing system failure in the baseflashings at its perimeter. Alternative low-slope roofing systems that may be considered include both single-ply membranes and multiple-ply built-up roofing systems, which provide significantly different service lives. Options that should be evaluated to comply with the Environmental Sustainability Policy for the City of Hyattsville (the “Sustainability Policy”) include high-albedo roof coverings, vegetated roof systems, and supplemental thermal insulation. A detailed cost-benefit analysis of alternative roofing systems is recommended.

**Photograph 27:** An overview of the low-slope roofing system. River-washed gravel ballast overlays a 60-mil EPDM membrane roof, loose-laid over rigid insulation.

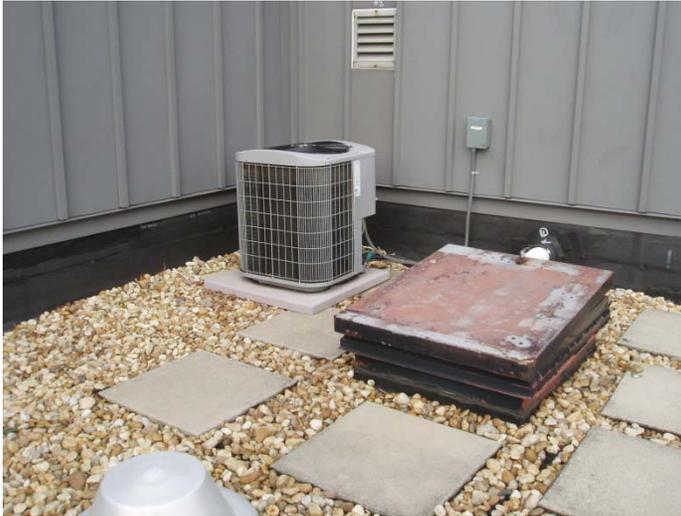
For the IT server room on the 3<sup>rd</sup> floor, a cooling-only split system has been added (Photograph 36). The indoor AC section is set at the floor with a bottom return air arrangement and a top discharge supply air duct distribution system. The unit's capacity is three tons. The condensing section is located on the roof above the server room.

**Photograph 36:** Split system condenser for indoor AC unit serving IT LAN/Server room.

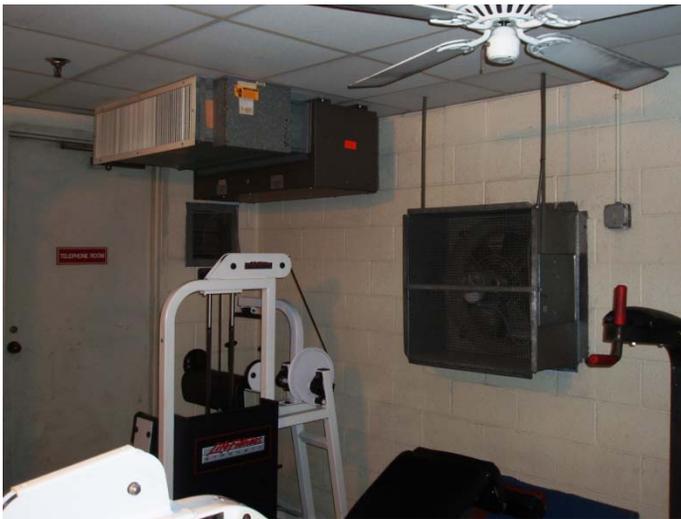
The garage is ventilated by a wall fan, WF-1, which discharges into an areaway below grade (Photographs 37, 38). The current ventilation rate of the fan is 0.5 CFM/sqft for the garage space. The wall fan is interlocked with a motor operated damper which opens when the fan is energized. The garage is heated with horizontally suspended electric fan coil units (Photograph 39).

**Photograph 37:** View of a ceiling-mounted heater and a wall-mounted exhaust fan in the northwest corner of the parking garage.

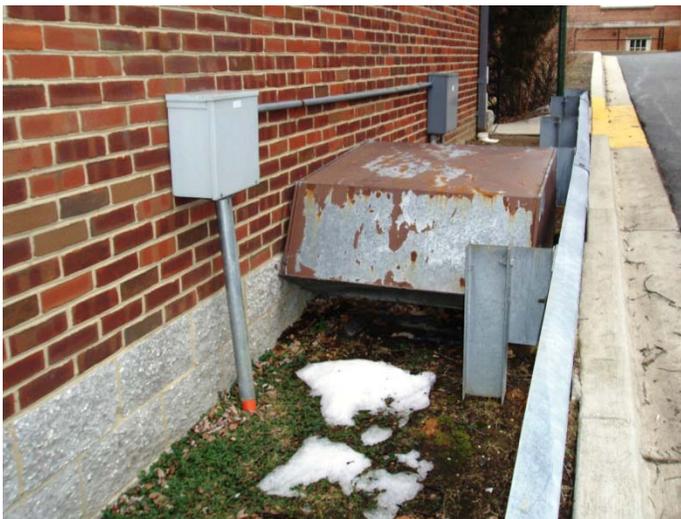
**Photograph 38:** Sheet metal hood at the top of the exhaust ductwork connected to the garage exhaust fan.

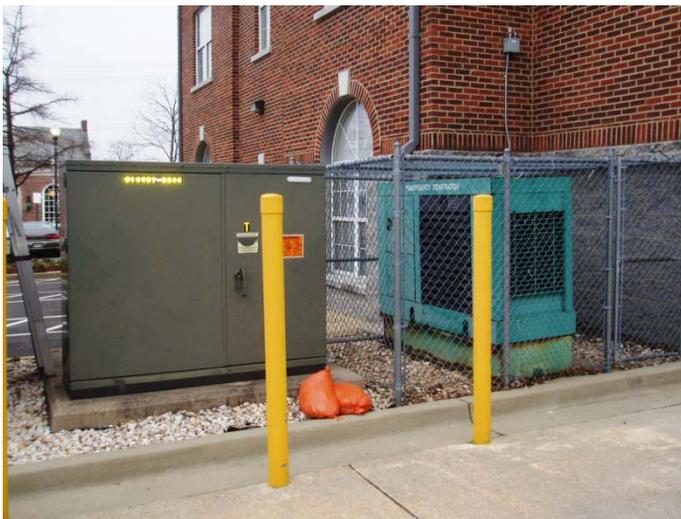
The electrical service consists of a pad mounted transformer (Photograph 41) supplying a 2000 Amp, 3 phase, 4 wire, switchboard located in the main electrical room, which powers the building. A 60kW emergency generator is installed adjacent to the pad mounted transformer located in the vicinity of the loading dock. The emergency generator feeds the ATS located in a separate room located adjacent to the main electrical room on the first floor in the garage.

**Photograph 41:** Transformer and emergency generator, mounted on concrete slabs adjacent to the loading dock area on the east end of the building.

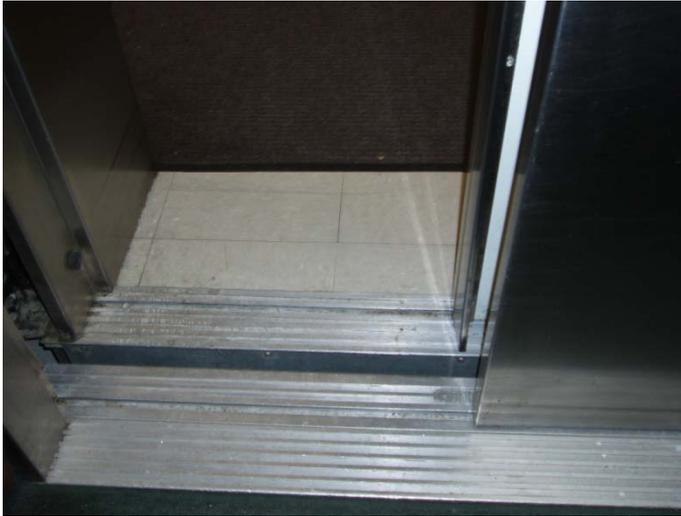
**Photograph 42:** View of the elevator car threshold at the 2<sup>nd</sup> floor landing. The elevator car threshold properly aligned with the door threshold at all levels during the inspection. Door and safety operations were acceptable at all levels.

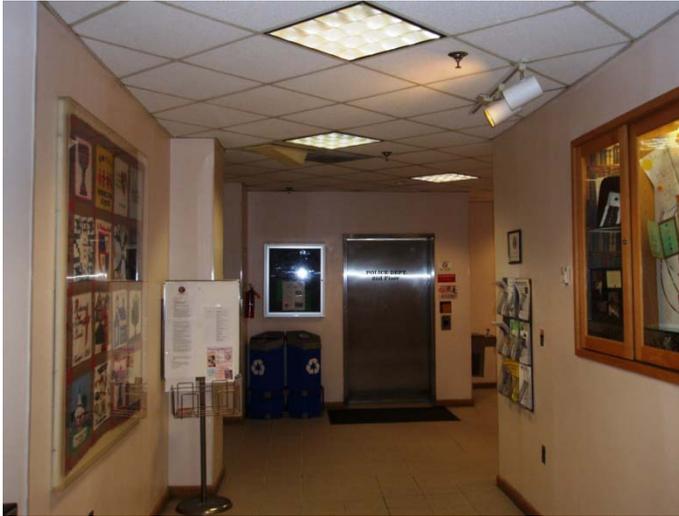
**Photograph 45:** View of main entrance lobby, looking toward the elevator from the vestibule.

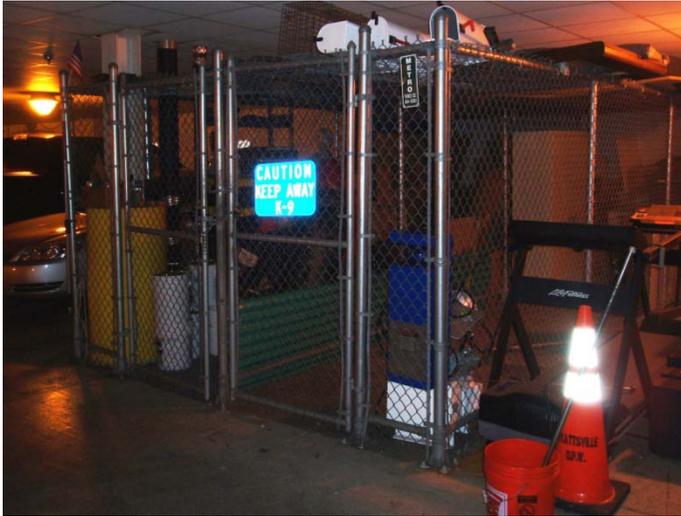
**Photograph 48:** A second caged storage area in the garage is also used as a kennel for the police department's service dog. This occupies one to two additional parking spaces in the garage.

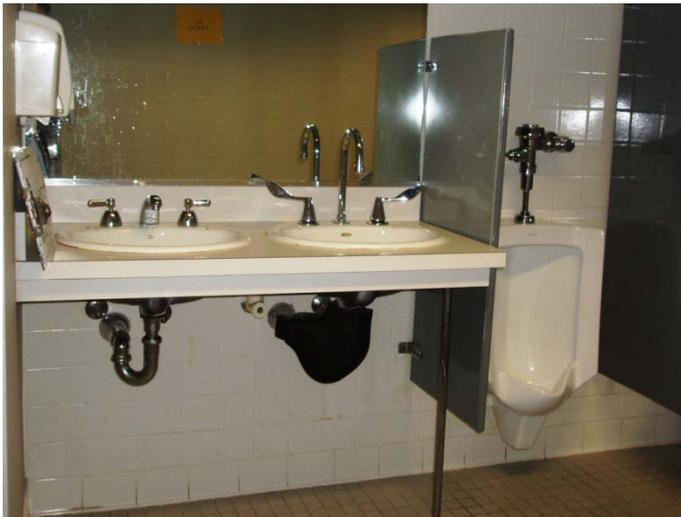
**Photograph 50:** View of lavatory sinks in the 3<sup>rd</sup> floor men's room.
