Hyattsville Accessibility Transition Plan

Burlington Park

Burlington Road and 46th Avenue

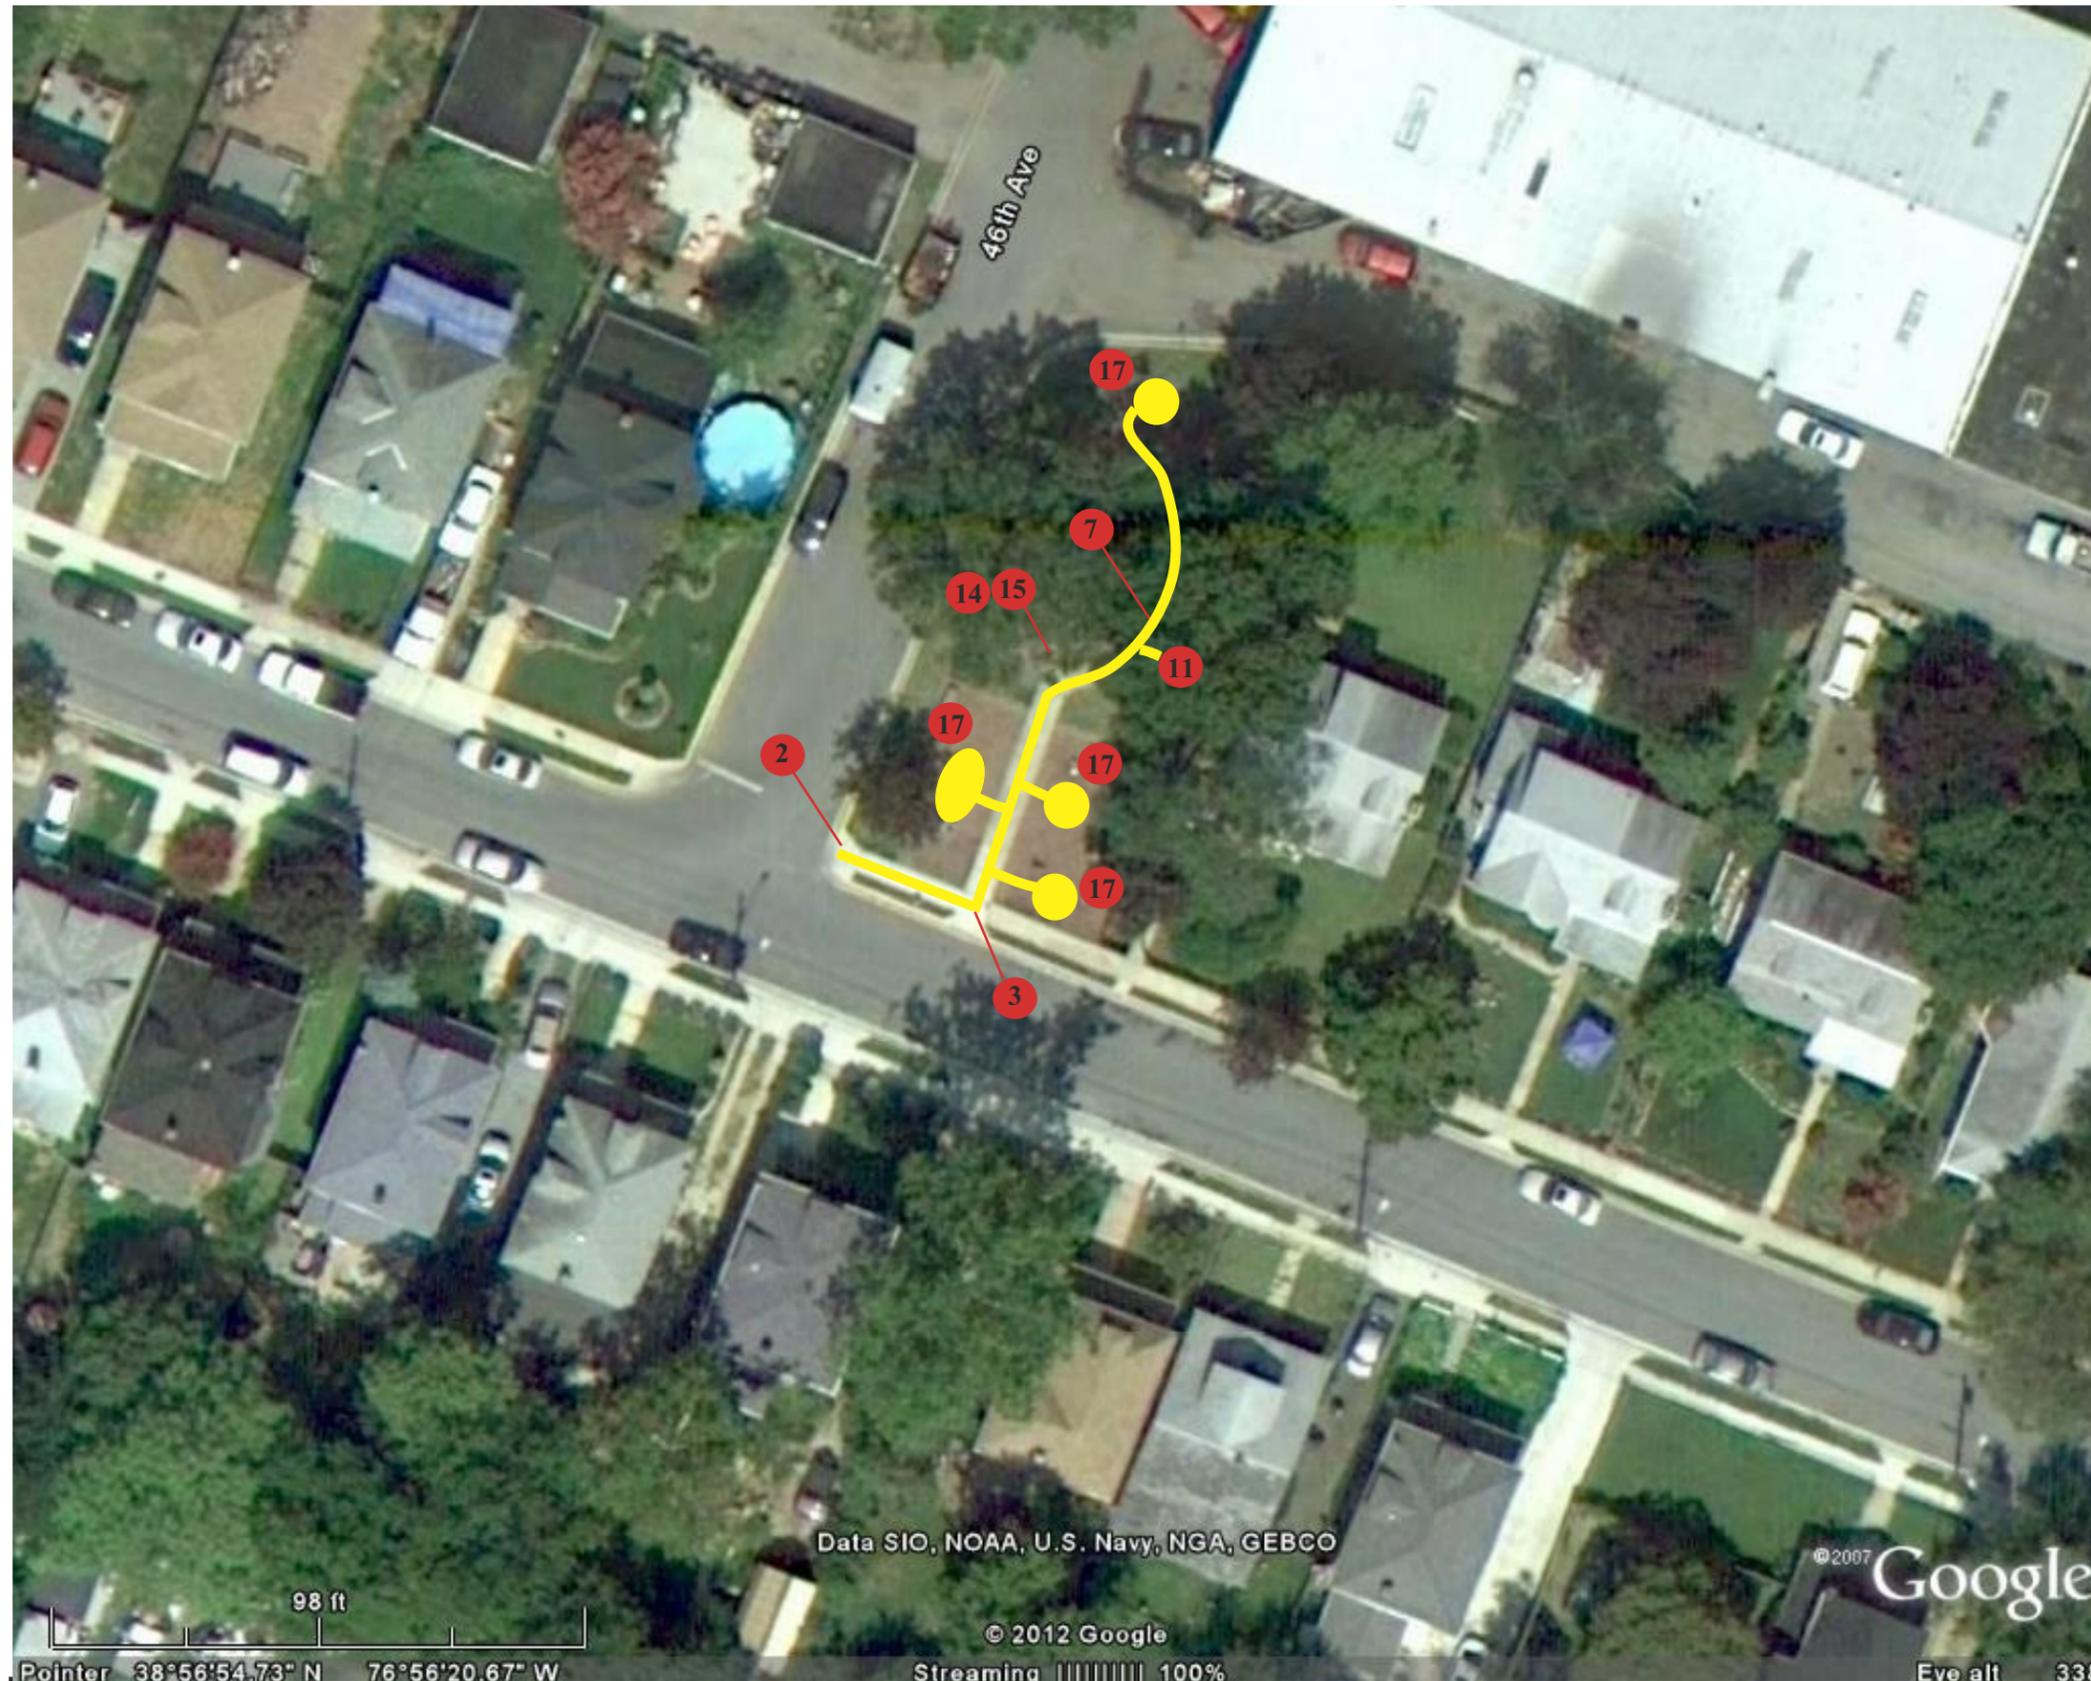
KEY

- Proposed solutions - see red item numbers on the Transition Plan spread sheets that follow this page

- Accessible route

- Accessible surface at play equipment (approximate area)

Note: Item numbers indicated in red, are keyed to the aerial site map for the facility. The aerial site map is on the first page of each facility section.

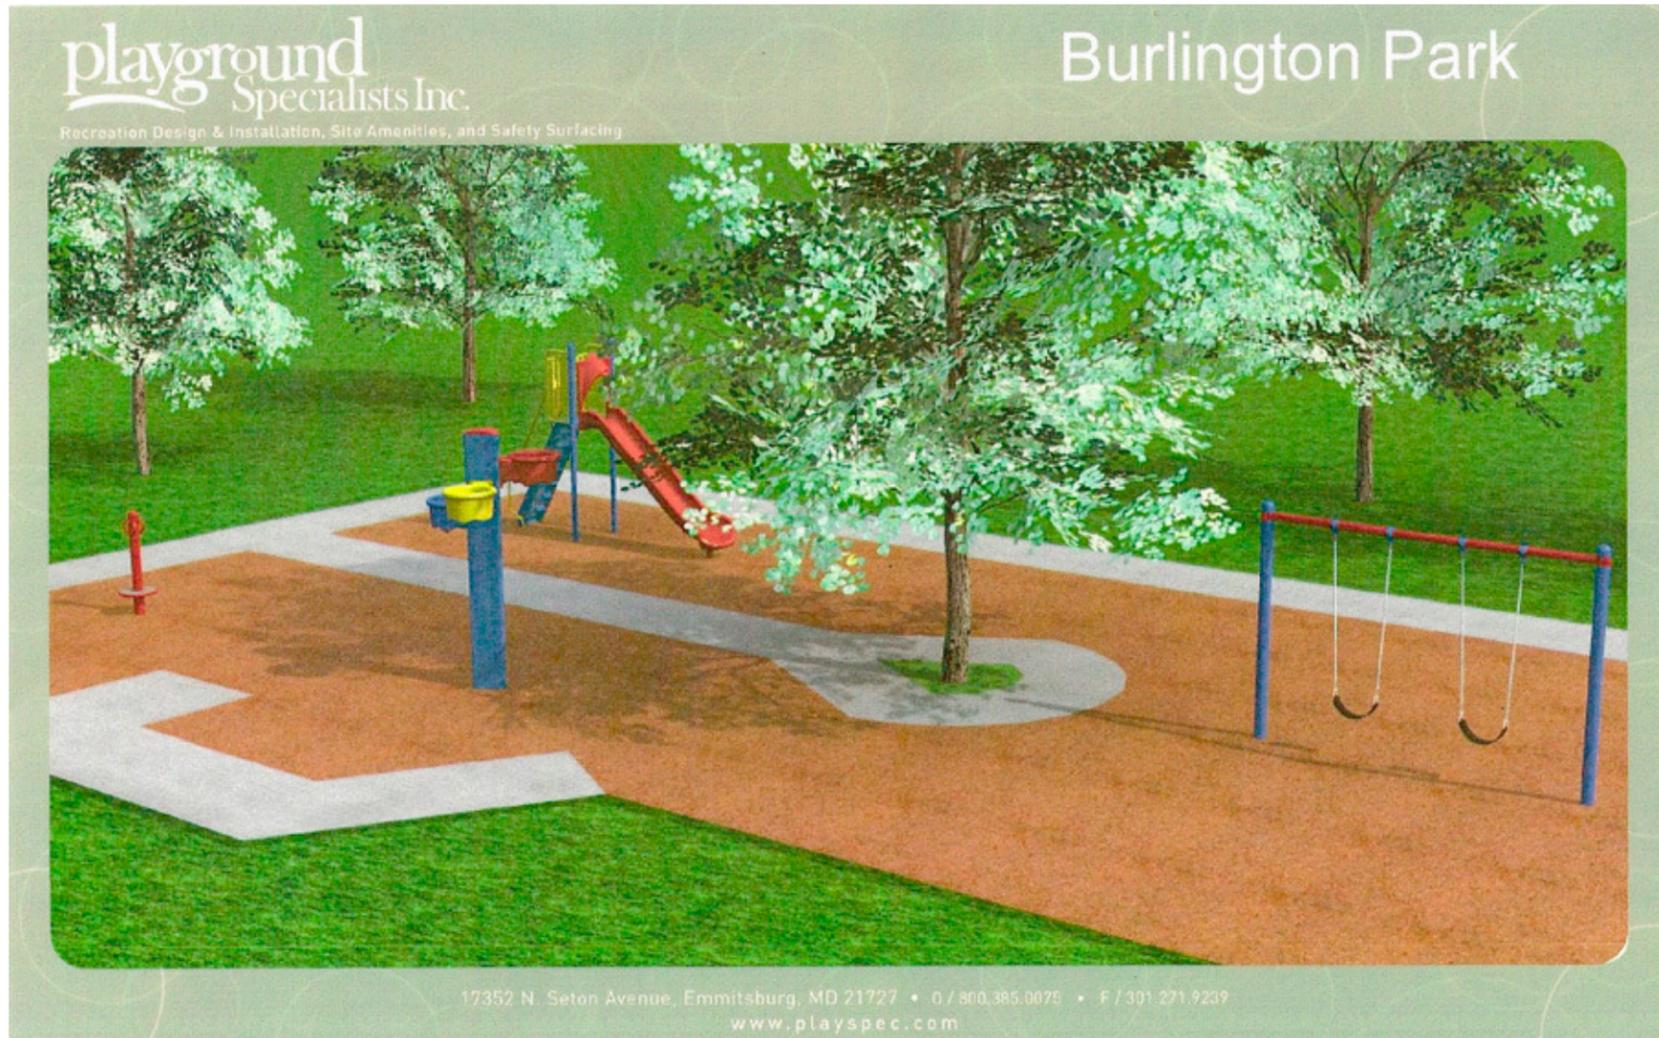
Sketch of new equipment installed at Burlington Park November 2011 (graphic provided by City of Hyattsville).
