Hyattsville Accessibility Transition Plan

Heurich Playground

Nicholson Street
(near Ager Road)

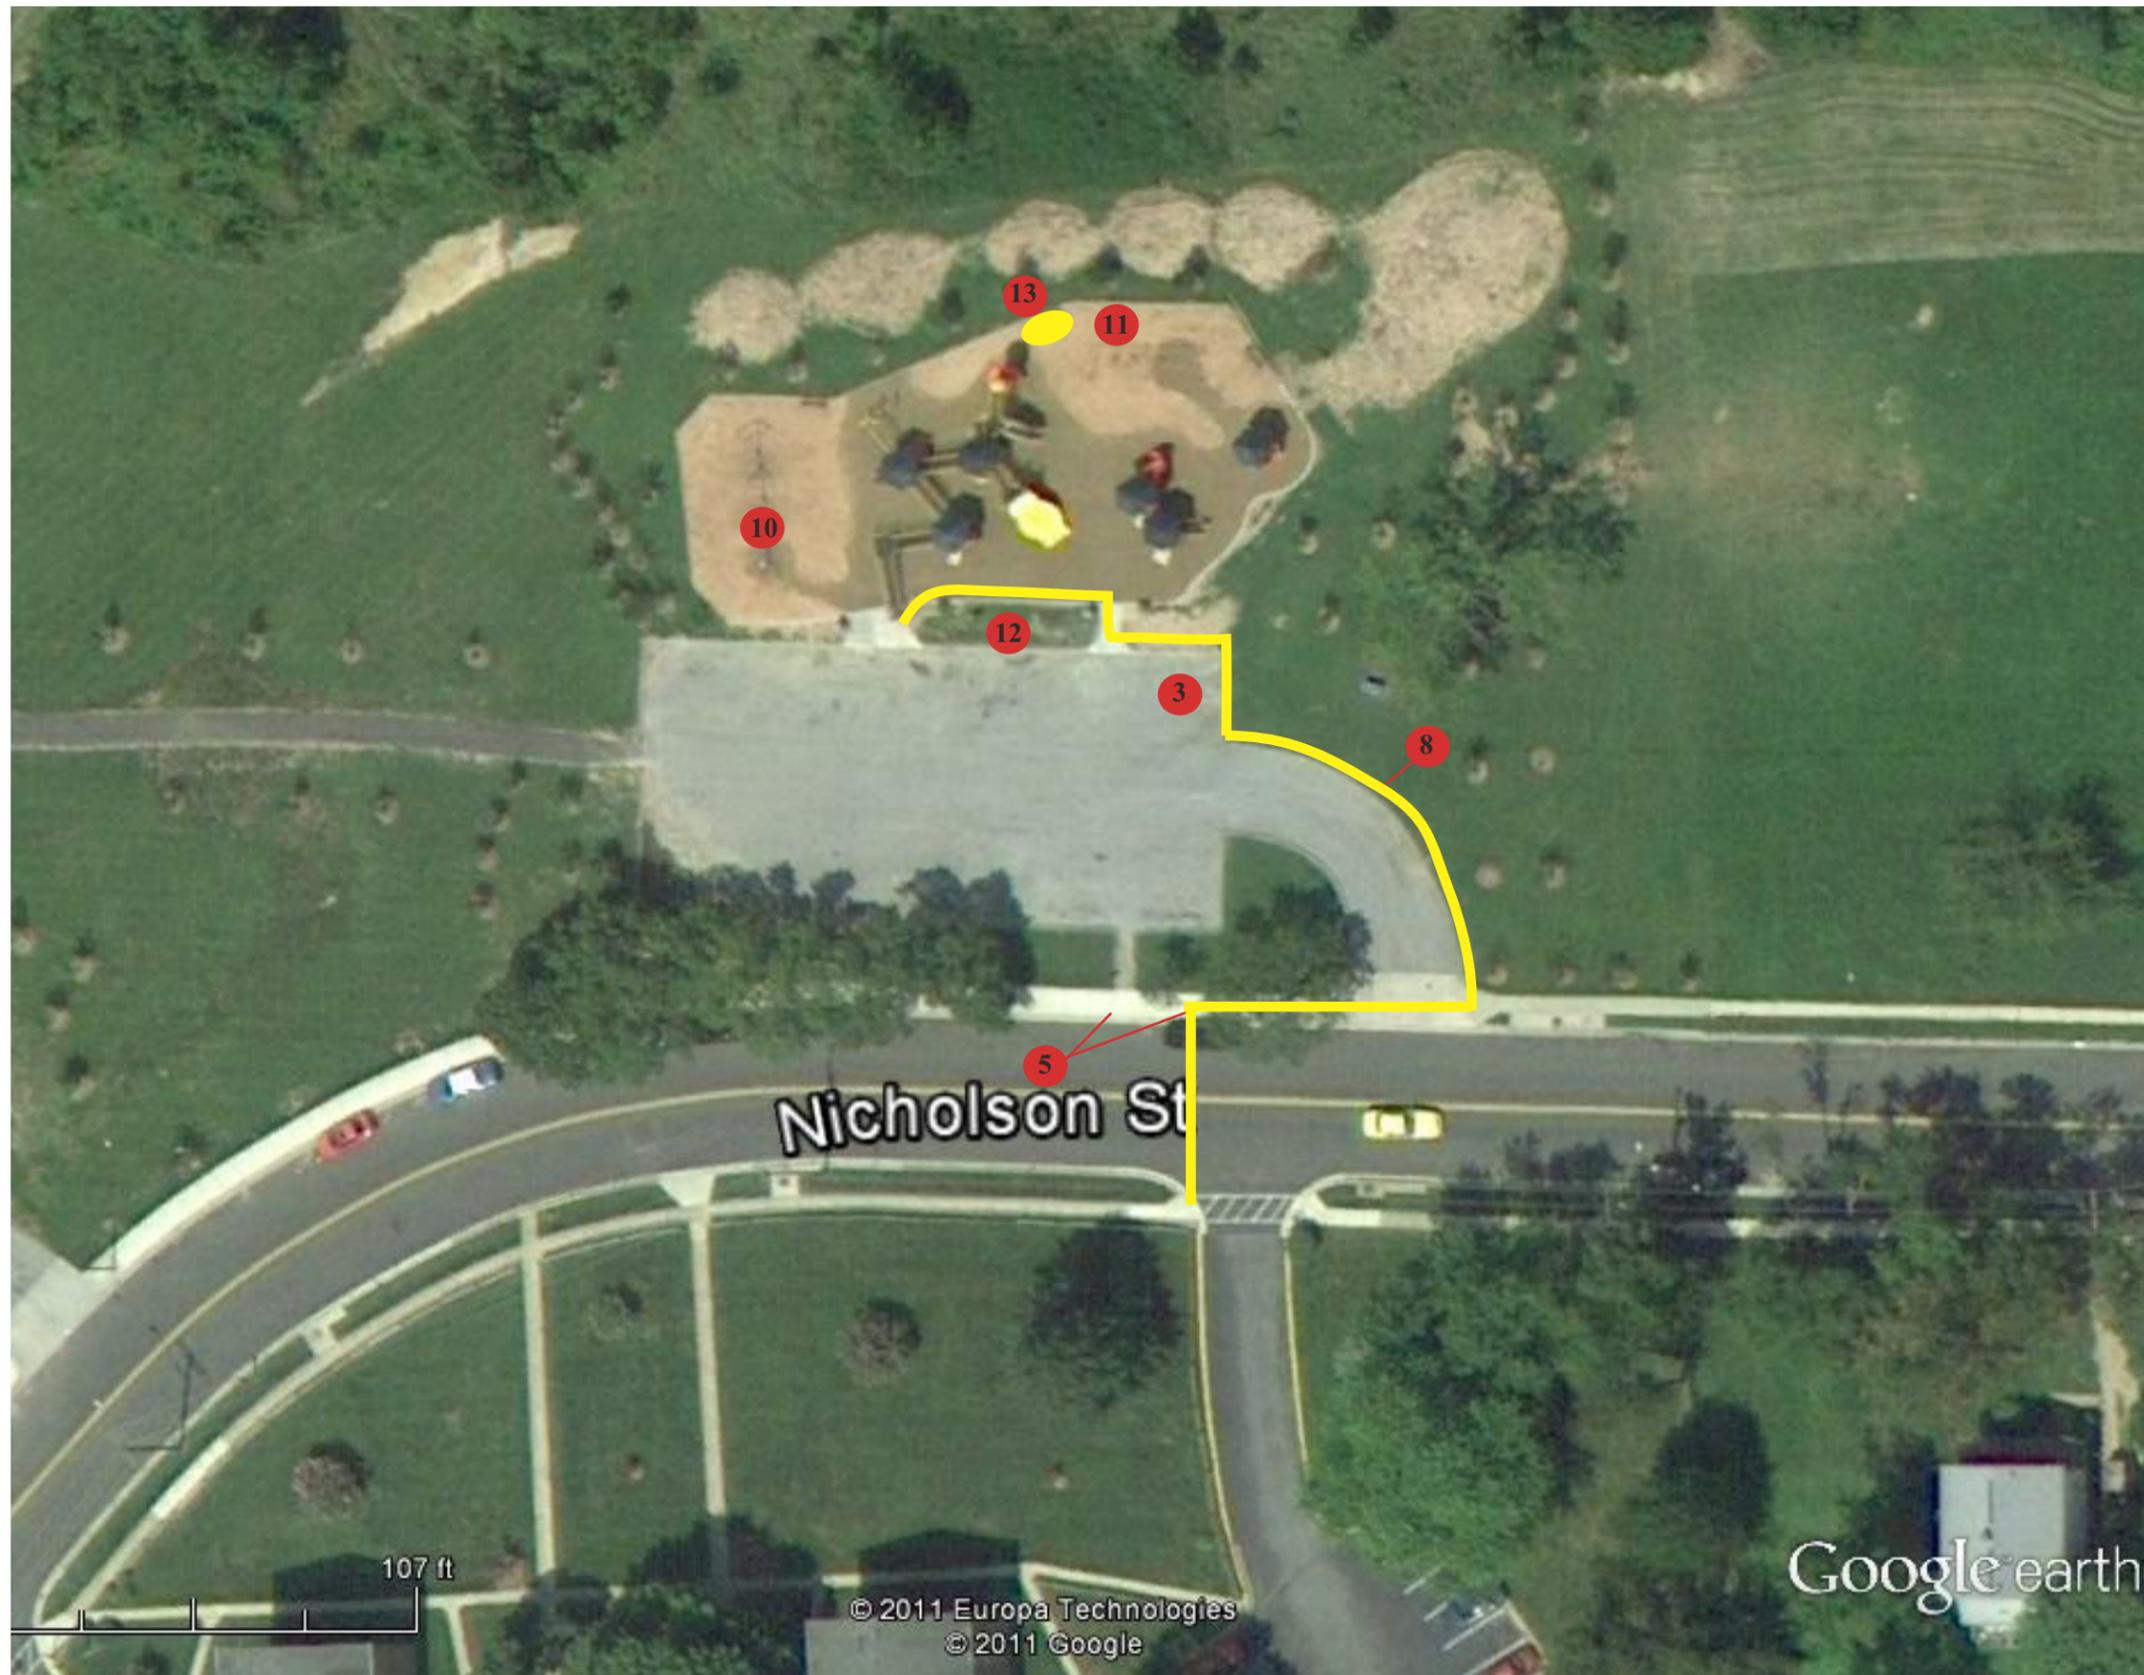
KEY	
Proposed solutions - see red item numbers on the Transition Plan spread sheets that follow this page

Accessible route

Accessible surface at play equipment (approximate area)

Note: Item numbers indicated in red, are keyed to the aerial site map for the facility. The aerial site map is on the first page of each facility section.
